Colusa County, CA

# **Stonyford-Lodoga Road, Pavement Distress Evaluation and Roadway Rehabilitation**

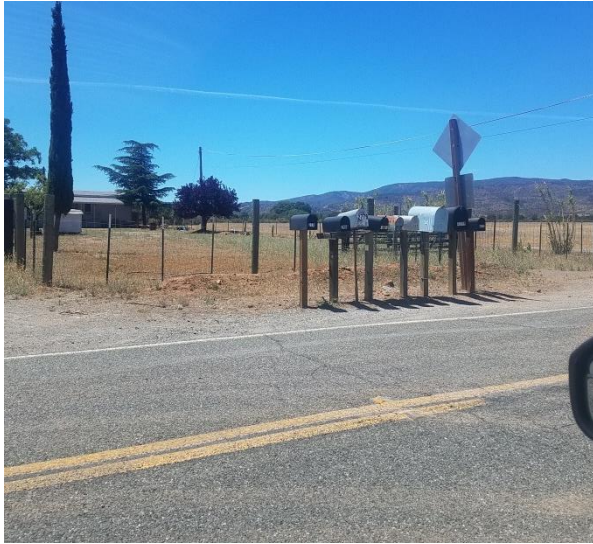
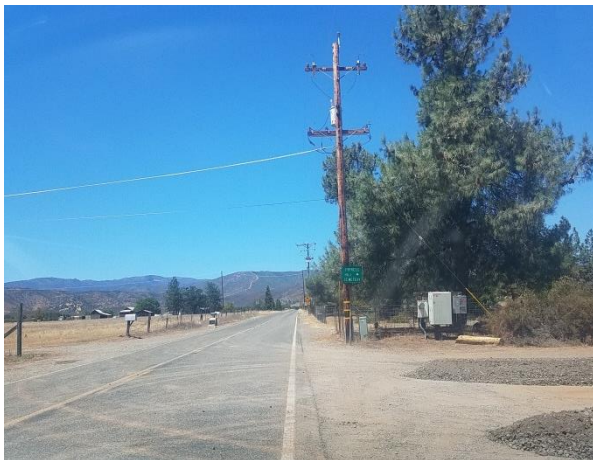
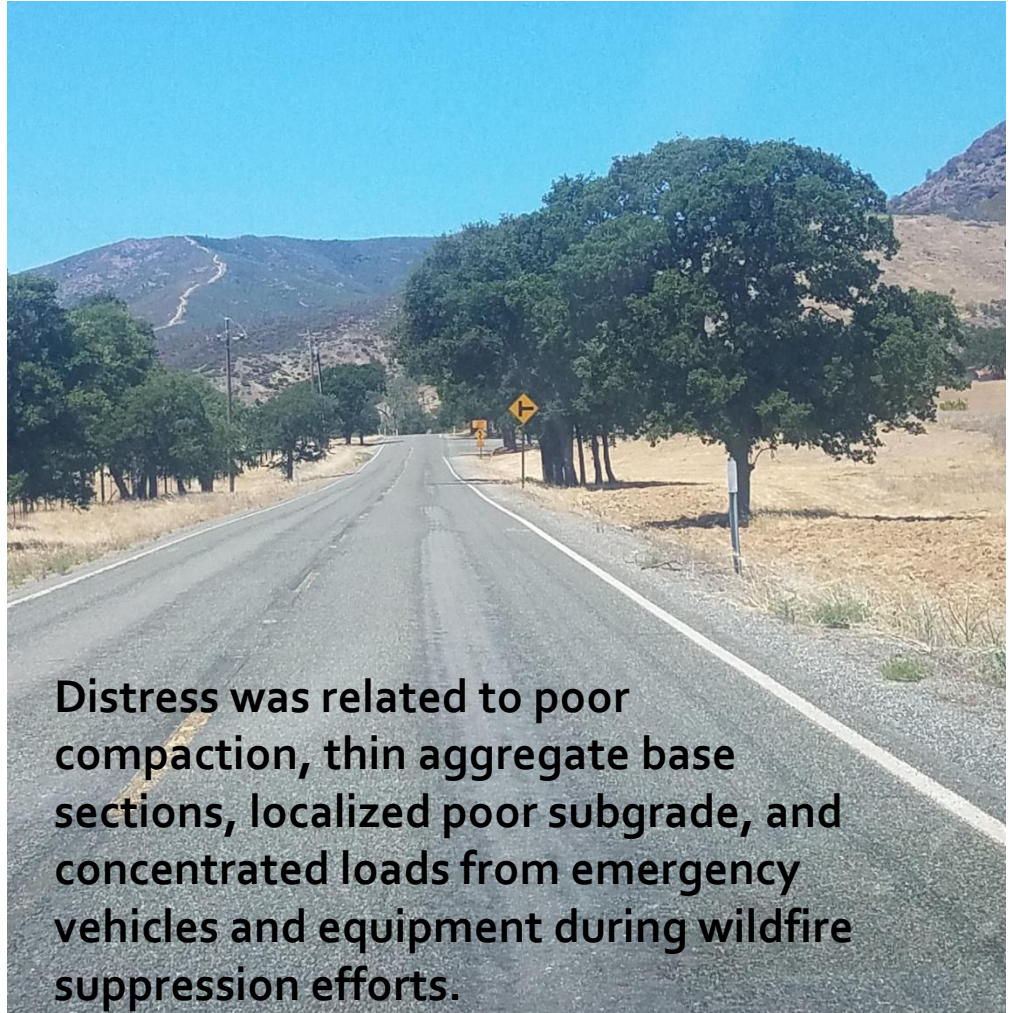
# Prior to Construction (2019)

Distress was related to poor compaction, thin aggregate base sections, localized poor subgrade, and concentrated loads from emergency vehicles and equipment during wildfire suppression efforts.

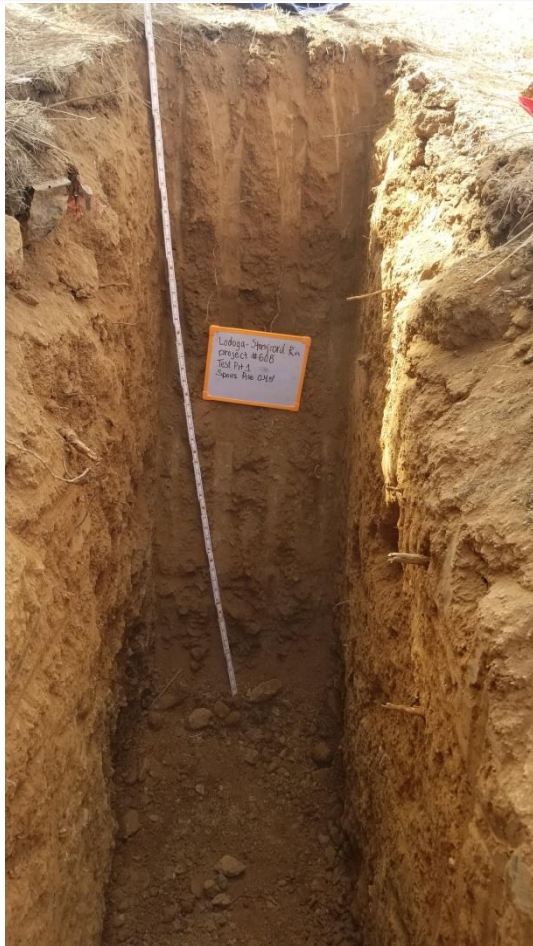
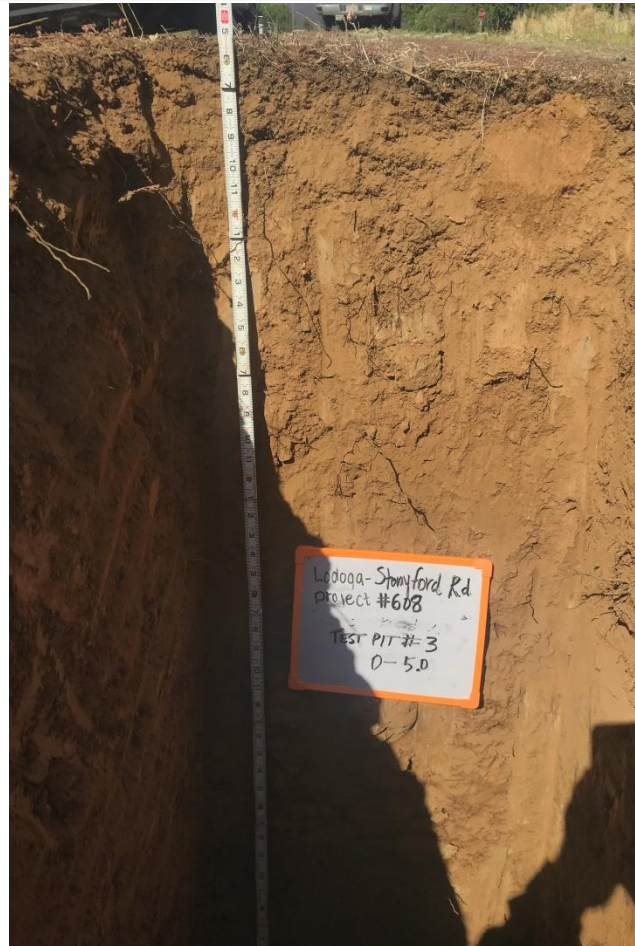
# Geotechnical Engineering (2019)

Project included logging and sampling six test pits to approximately a 5-foot depth, Dynamic Cone Penetrometer (DCP) testing six locations. Subsequently, geotechnical laboratory testing, engineering analyses, and submission of a geotechnical report with recommendations for pavement repair alternatives were completed.
