TRAFFIC FLOW IMPROVEMENT PHOTOS

WILSHIRE BLVD EAST OF FEDERAL AVE:
A peak period bus lane was added to the eastbound lanes

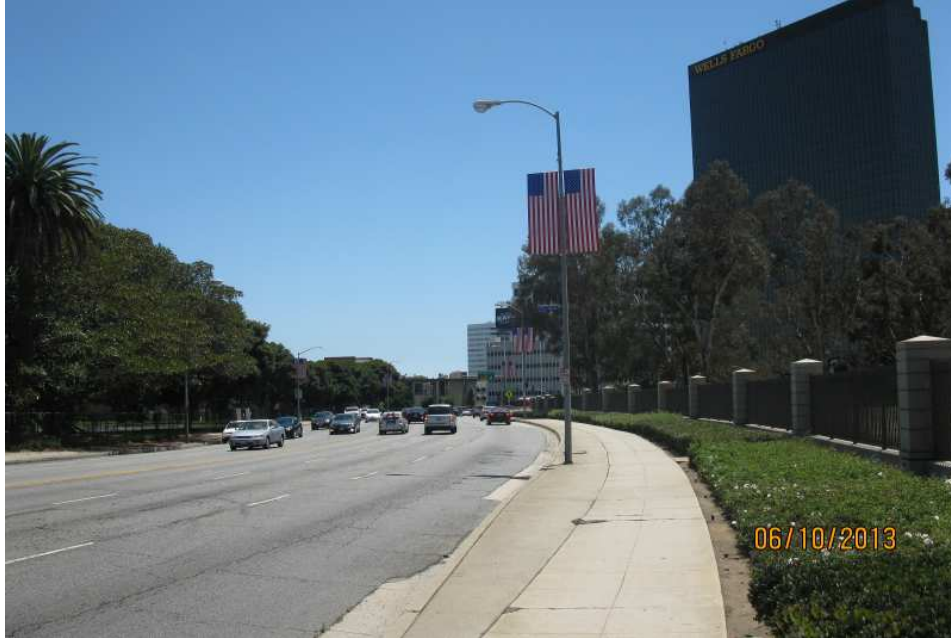
WILSHIRE BLVD BETWEEN BONSALL AVE AND SAN VICENTE BLVD:
An auxiliary lane was added to the westbound traffic

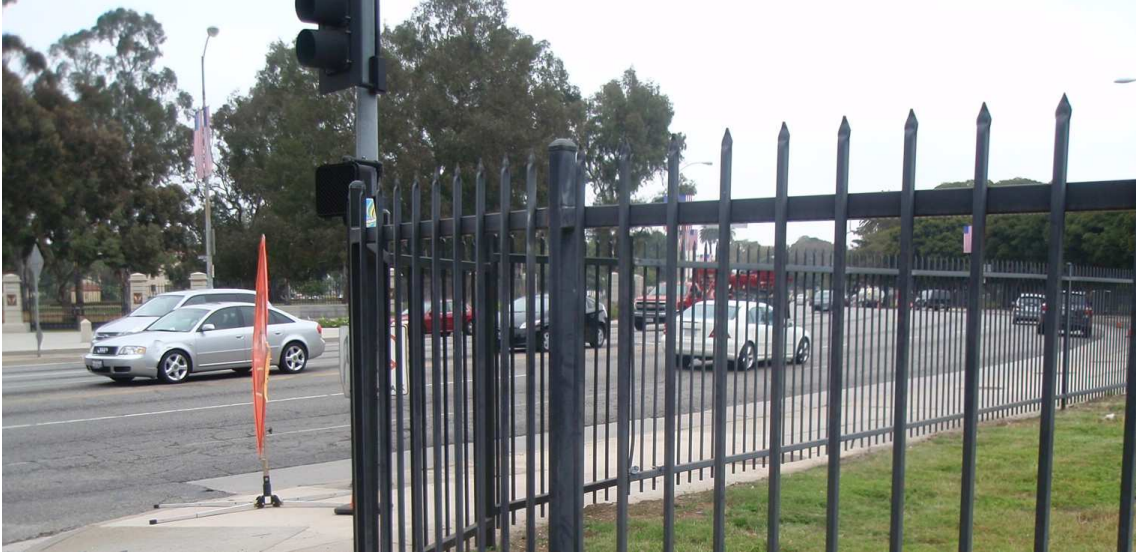
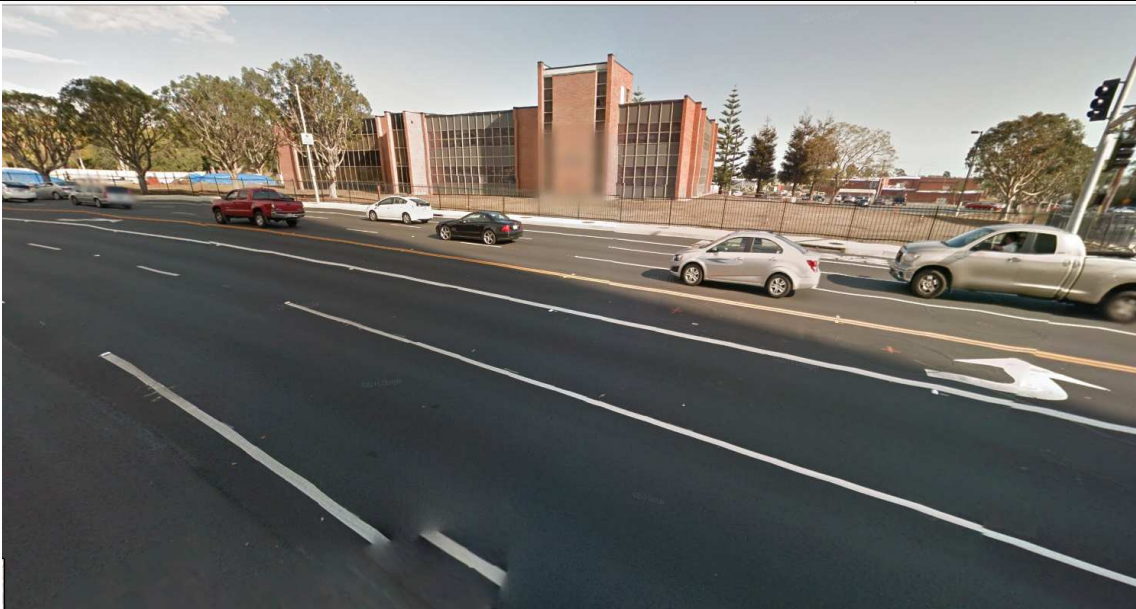
WILSHIRE BLVD AT FEDERAL AVE:
The left turn pocket was extended

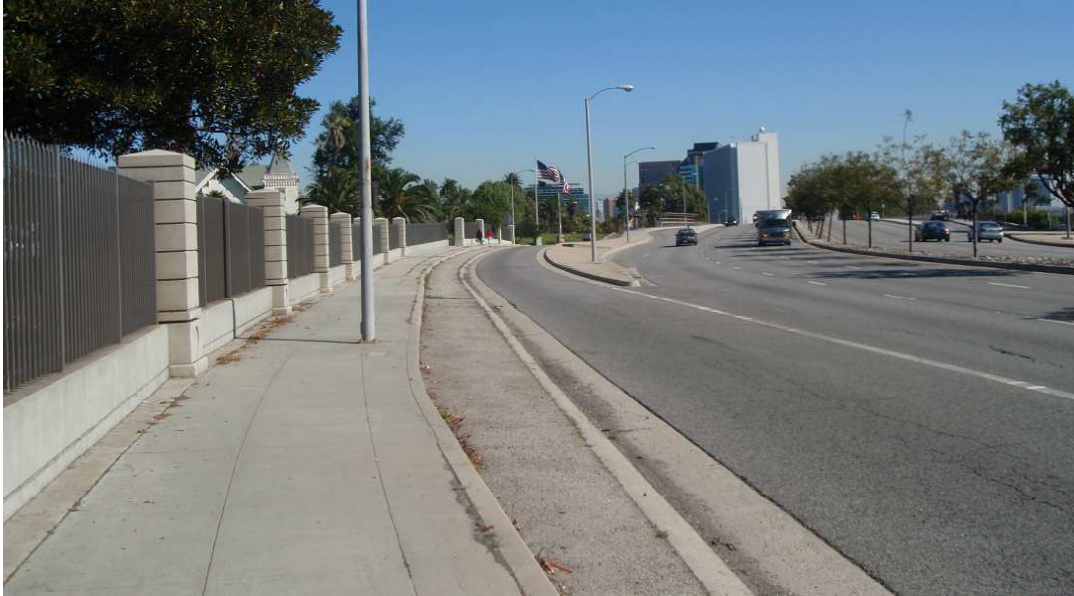
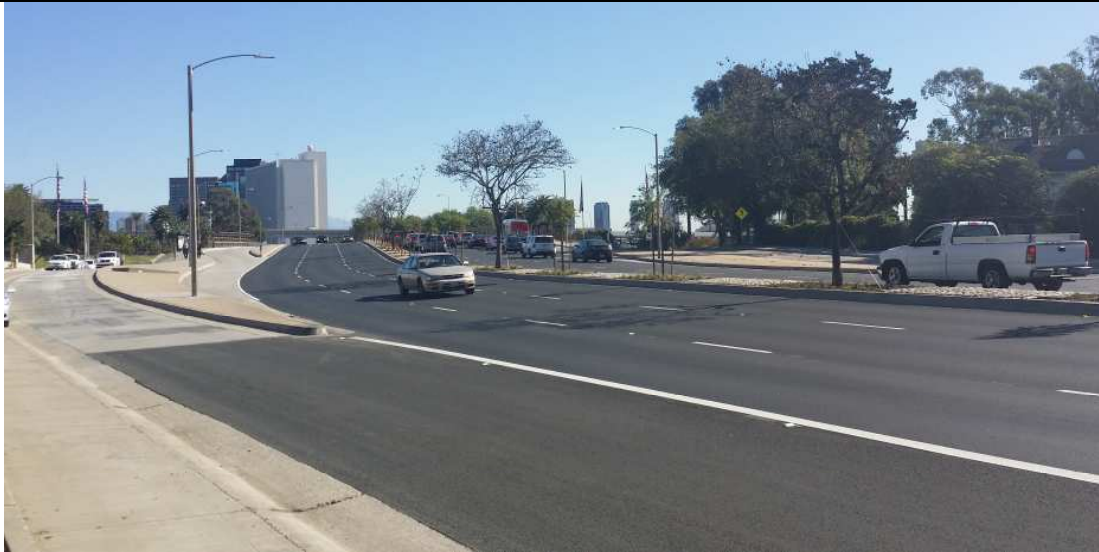
WILSHIRE BLVD AT WESTBOUND ON-RAMP:

Wilshire Blvd was rehabilitated with recycled tired rubber modified asphalt concrete pavement

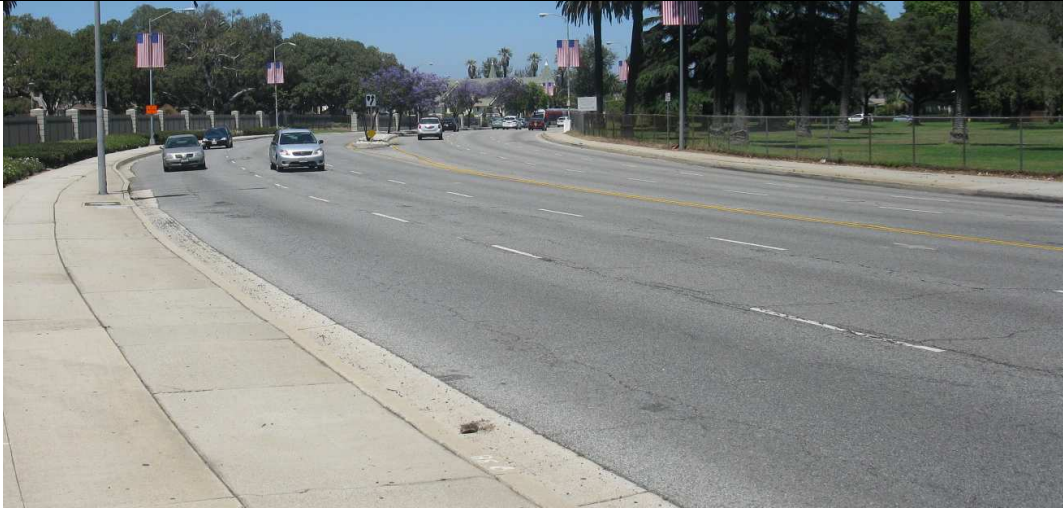
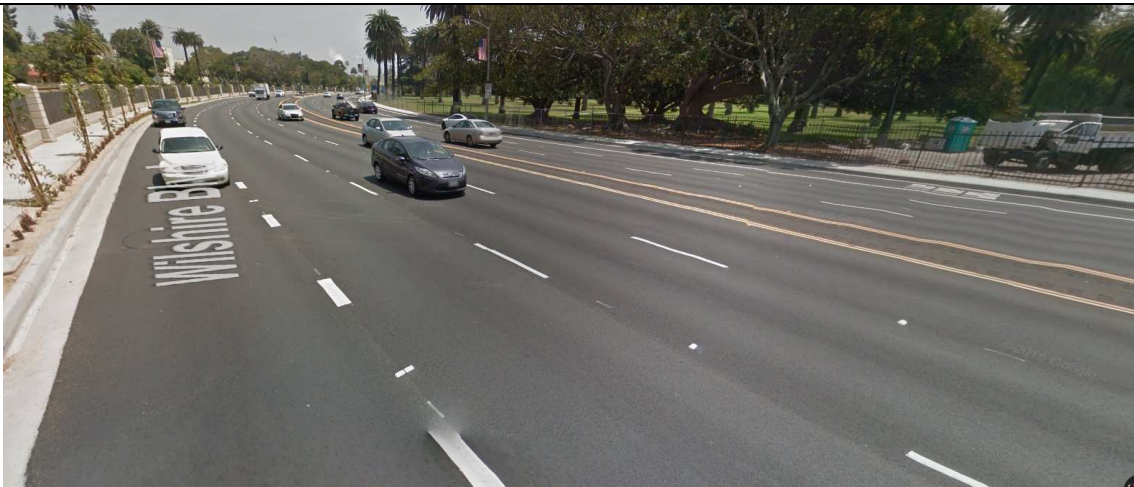
WILSHIRE BLVD:

The pavement was rehabilitated with recycled tired rubber modified asphalt concrete pavement.

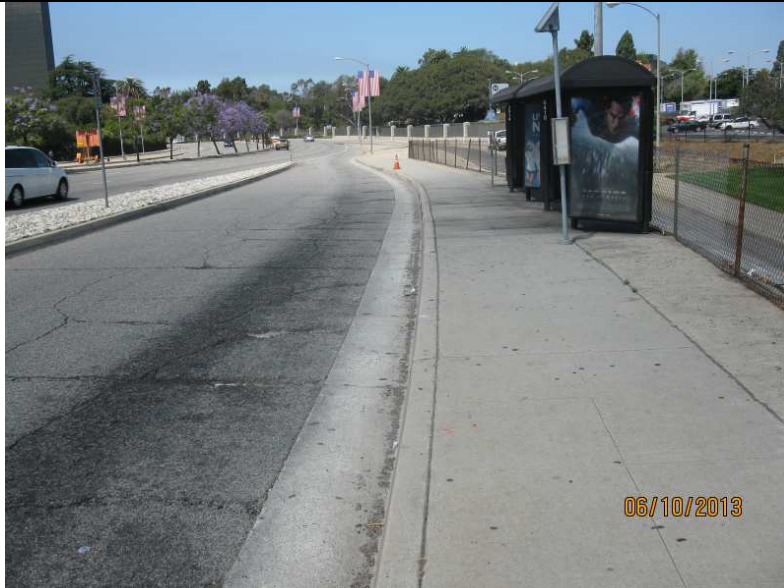
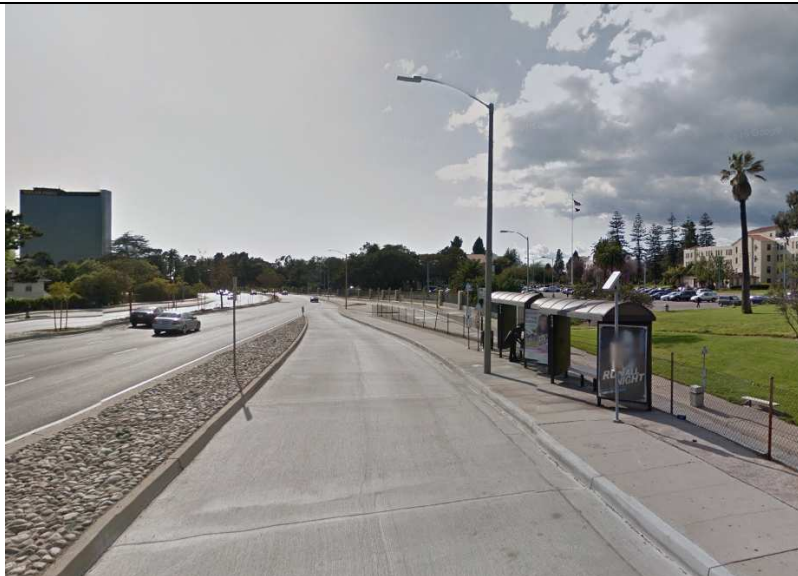
WILSHIRE BLVD WESTBOUND BUS TURN-OUT:

The bus turn-out pavement was rehabilitated with concrete pavement.

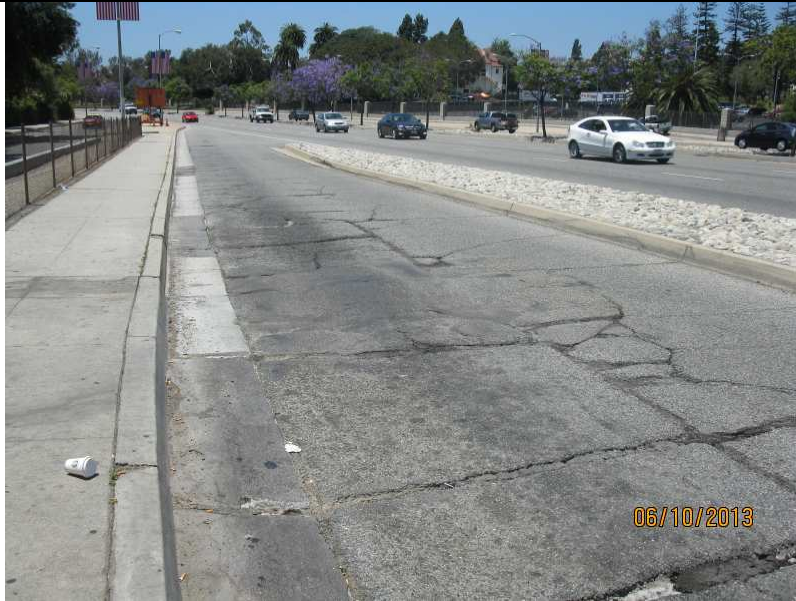
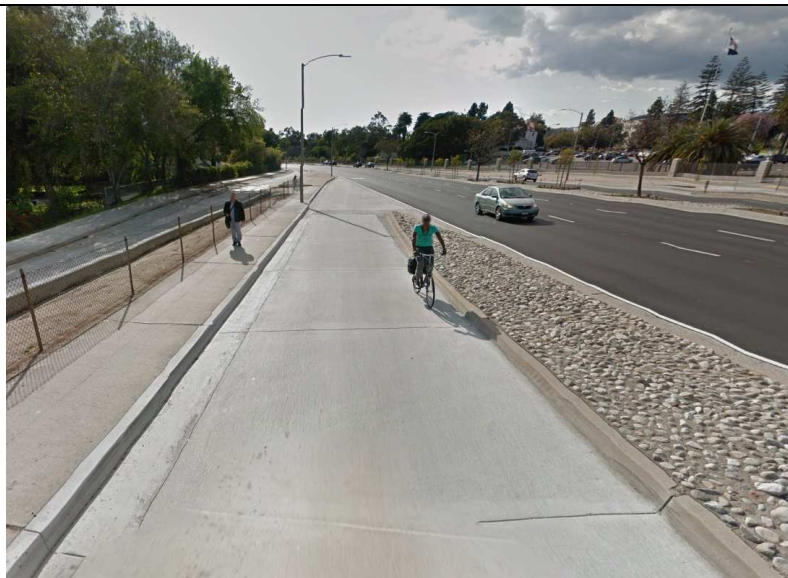
WILSHIRE BLVD EASTBOUND BUS TURN-OUT:

The bus turn-out pavement was rehabilitated with concrete pavement.

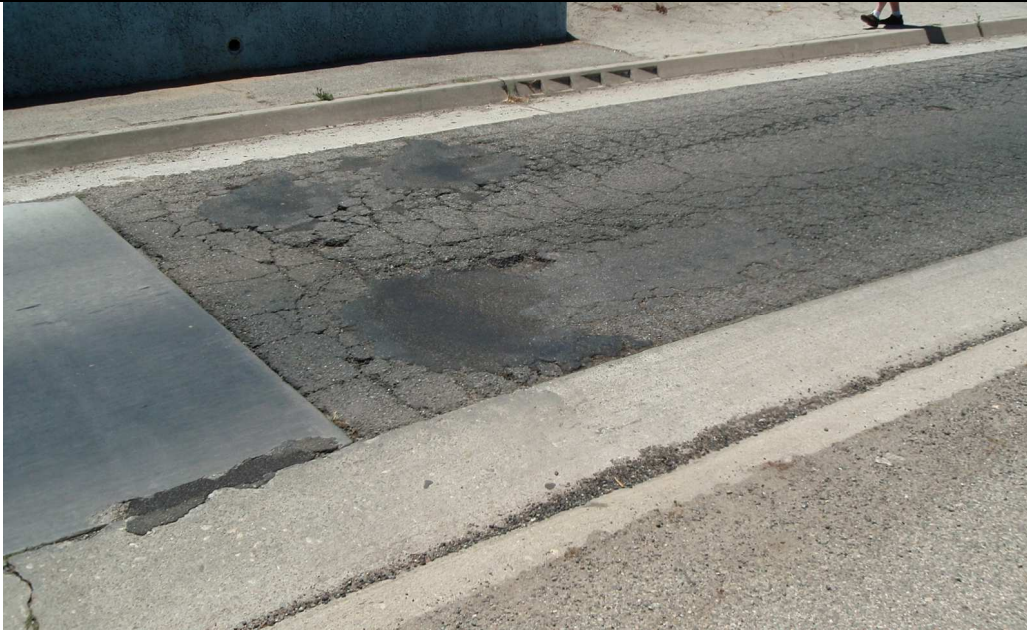
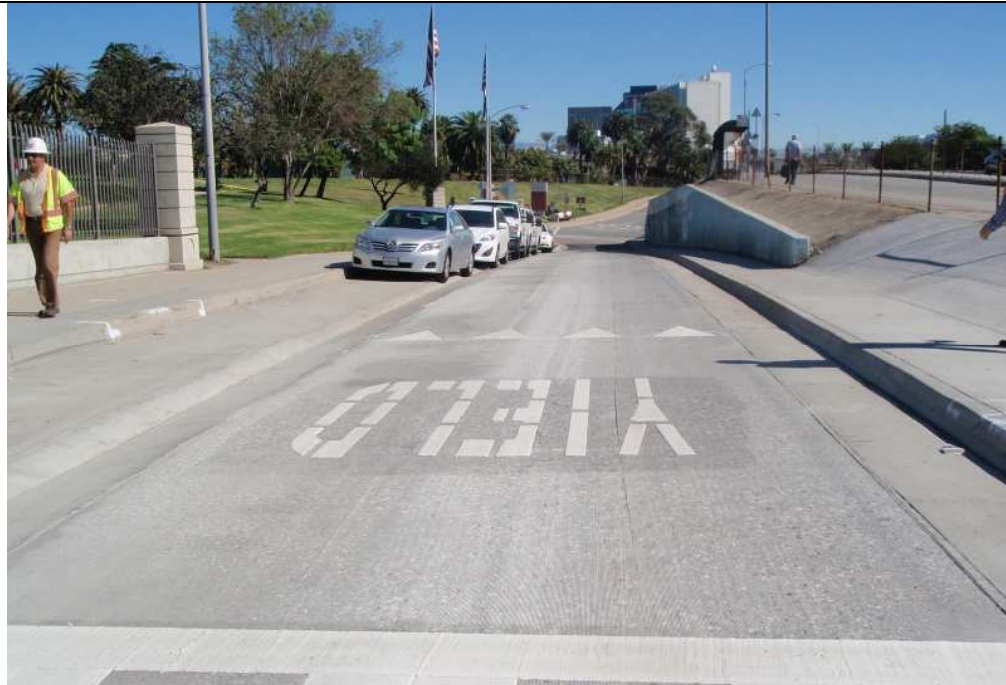
WILSHIRE BLVD WESTBOUND ON-RAMP:

The on-ramp pavement was rehabilitated with concrete pavement.

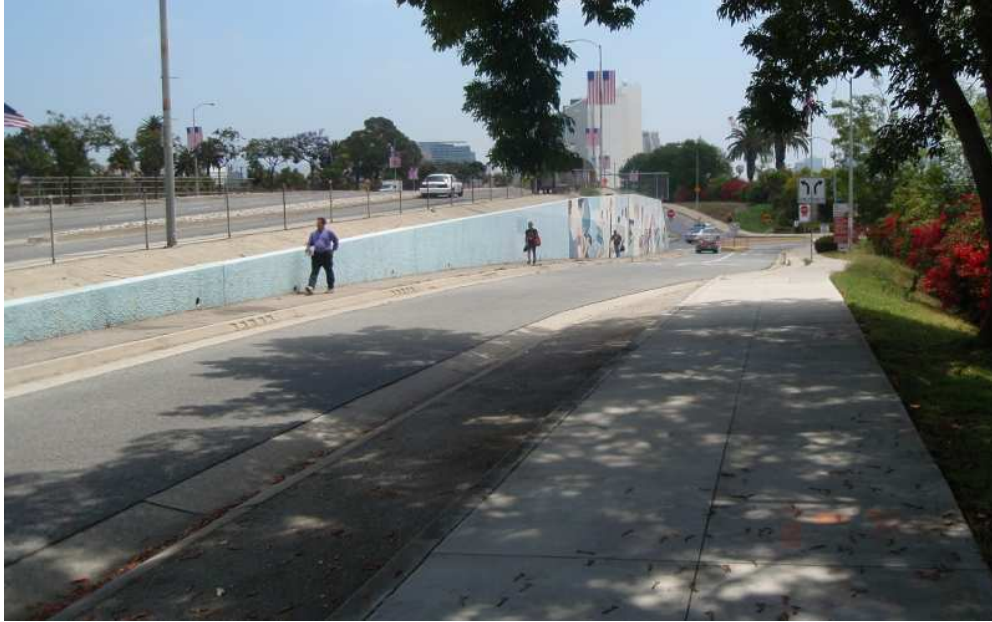
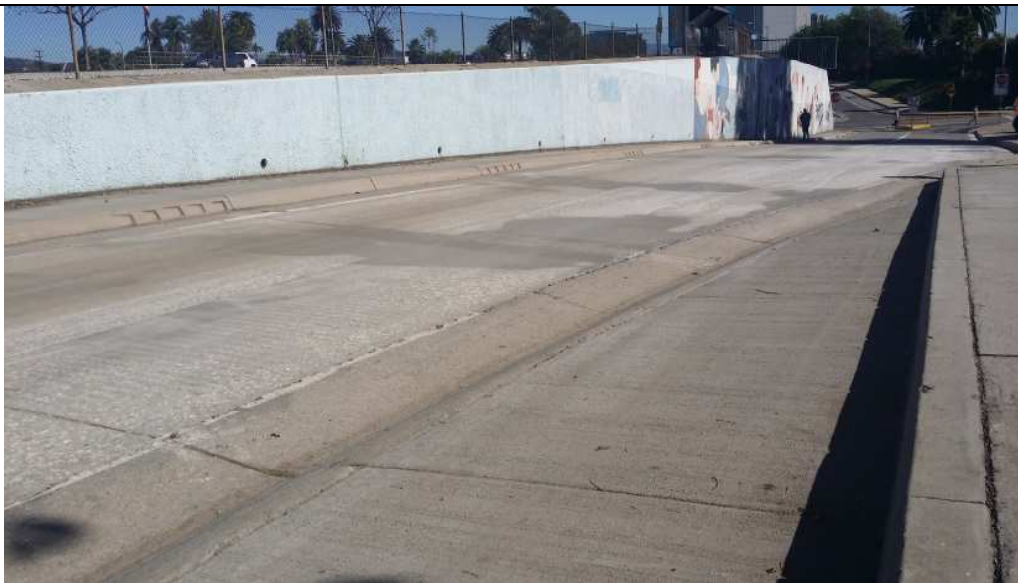
WILSHIRE BLVD EASTBOUND OFF-RAMP:
The pavement was rehabilitated with concrete pavement

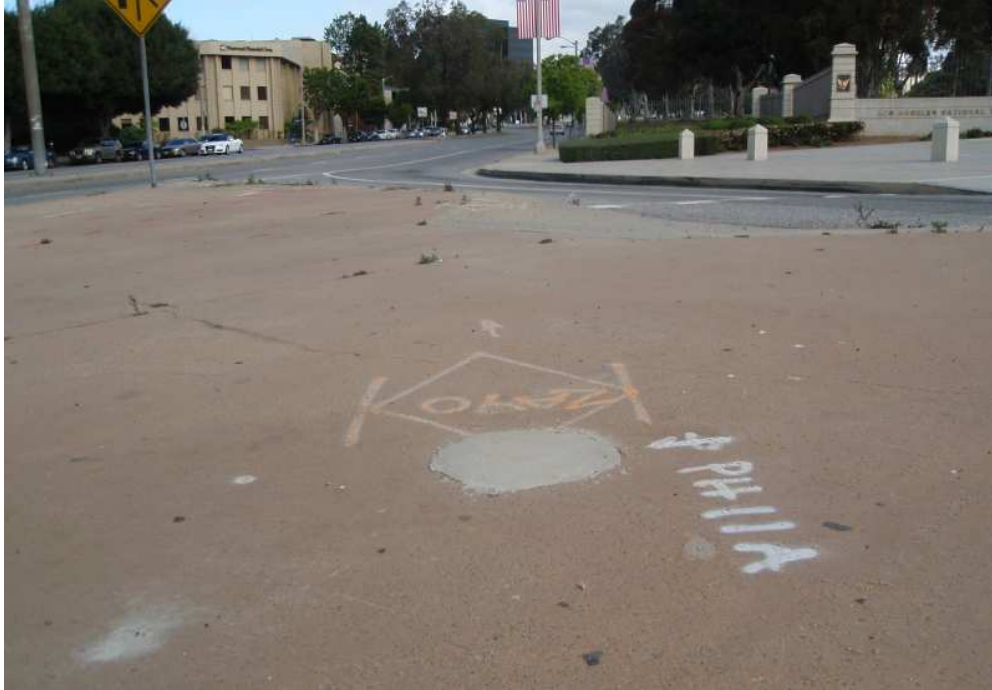
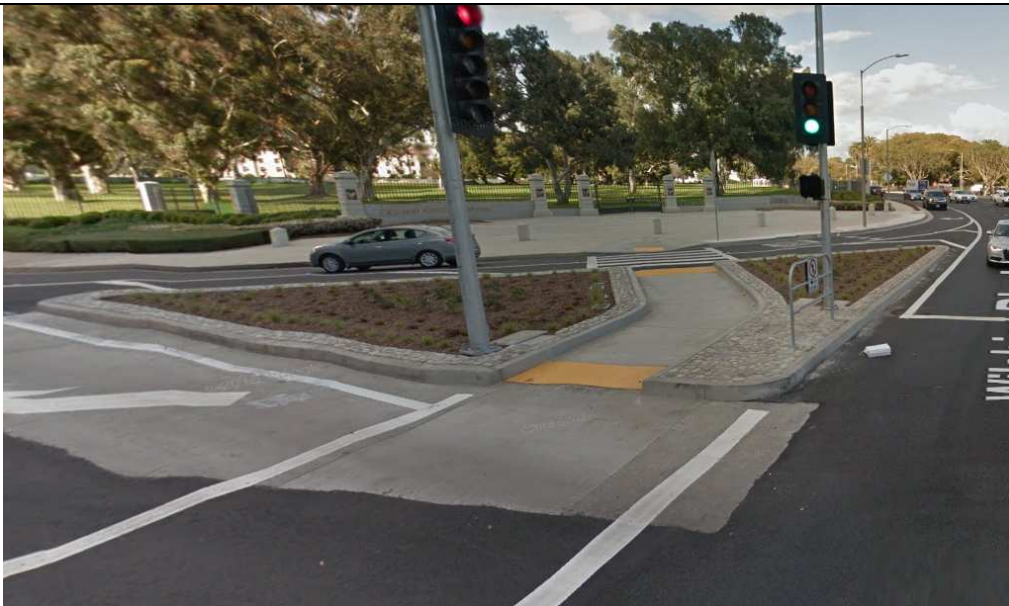
WILSHIRE BLVD AT SAN VICENTE BLVD TRAFFIC ISLAND:
A passageway was constructed through the existing traffic island

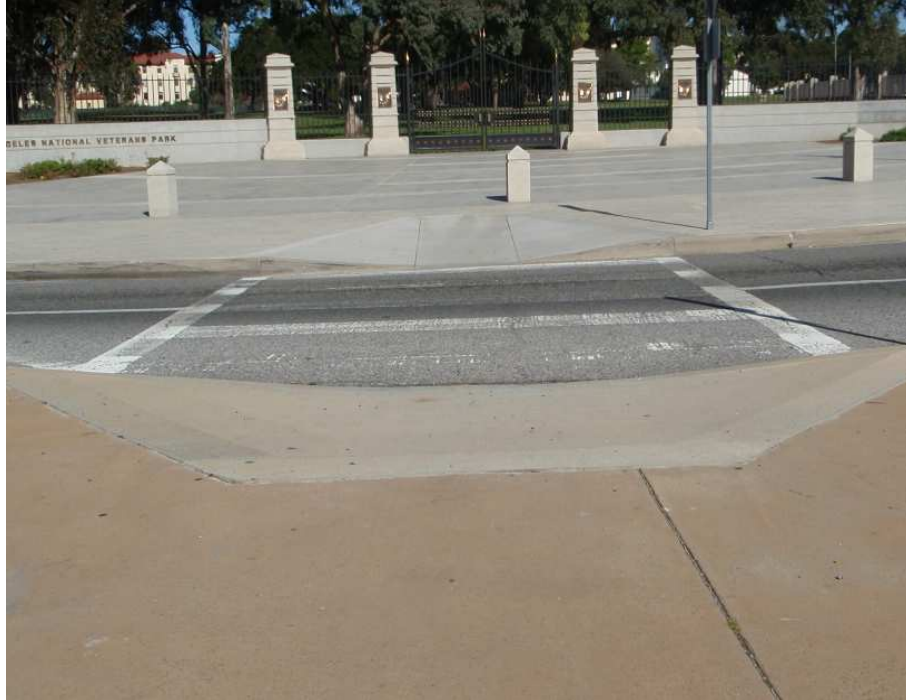
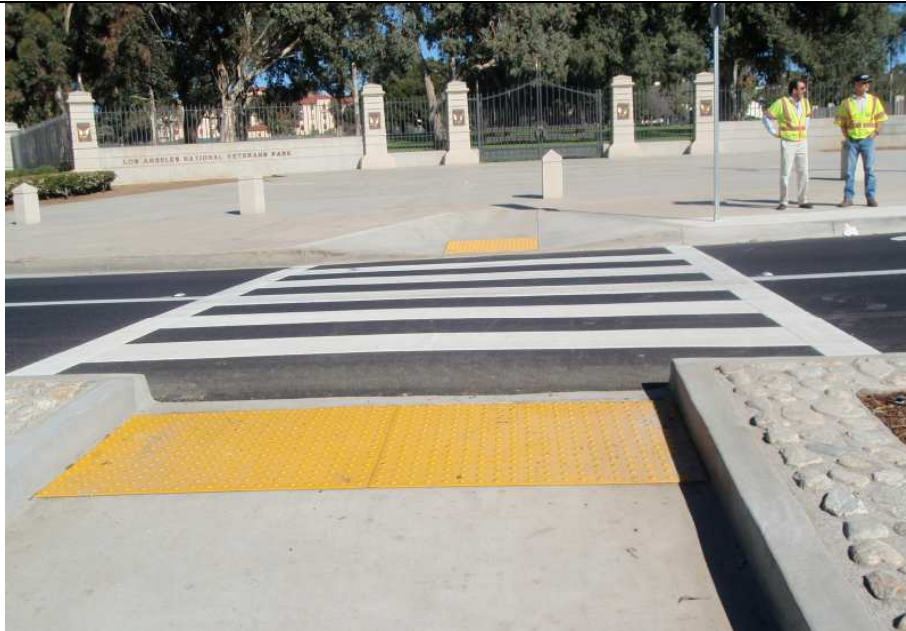
WILSHIRE BLVD AT SAN VICENTE BLVD TRAFFIC ISLAND:
The existing curb ramps to the traffic island were enhanced

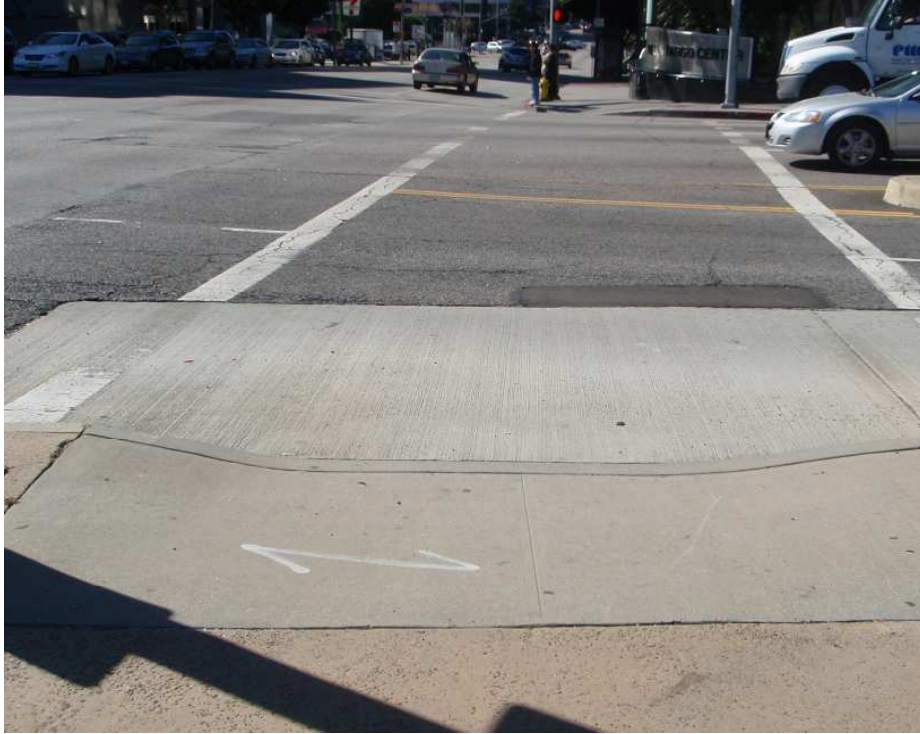
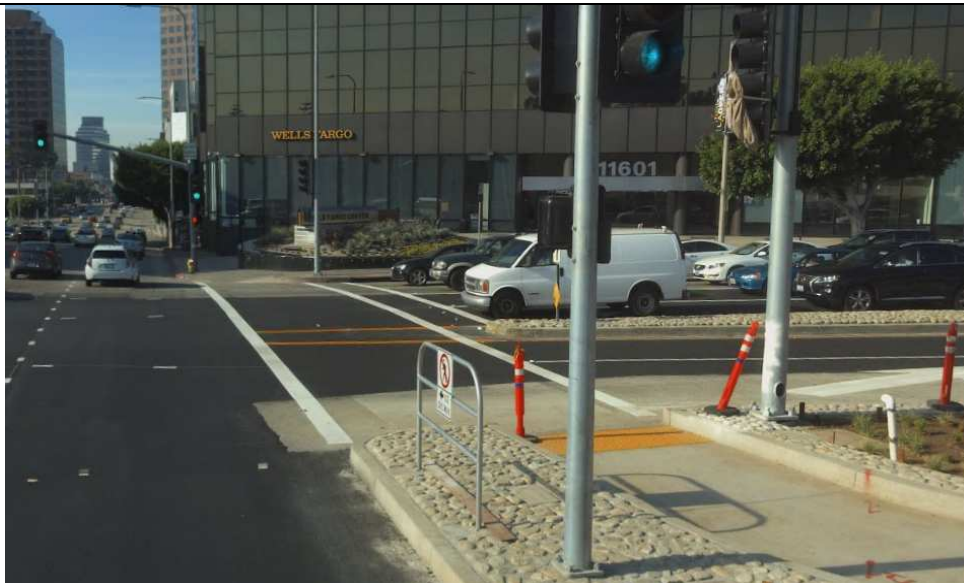
WILSHIRE BLVD AT SAN VICENTE BLVD:
Crossing from the traffic island to the west side of San Vicente Blvd

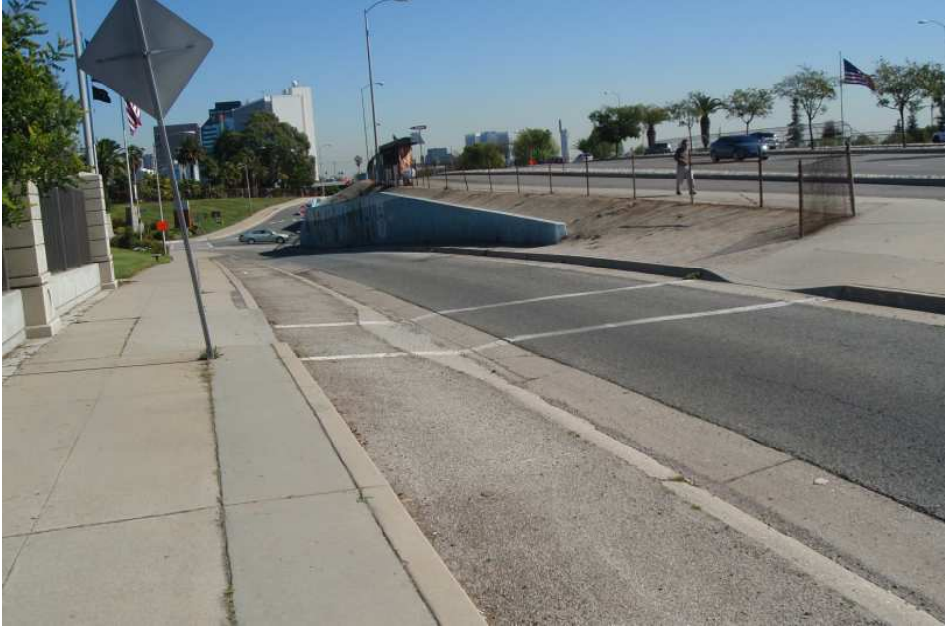
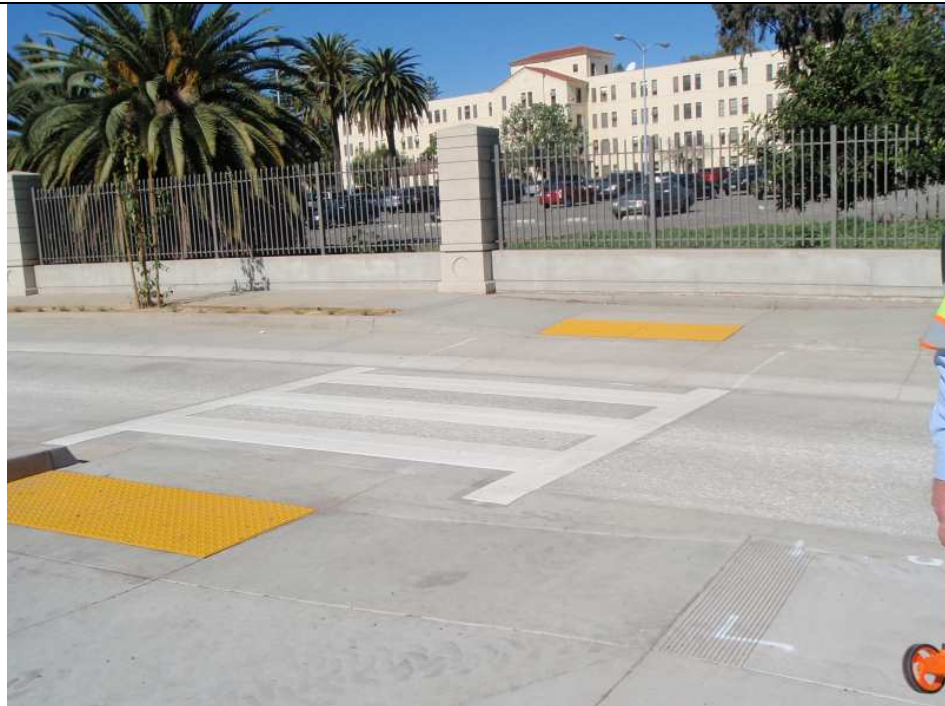
WILSHIRE BLVD WESTBOUND ON-RAMP:
Enhanced curb ramps at the crosswalk across the westbound on-ramp

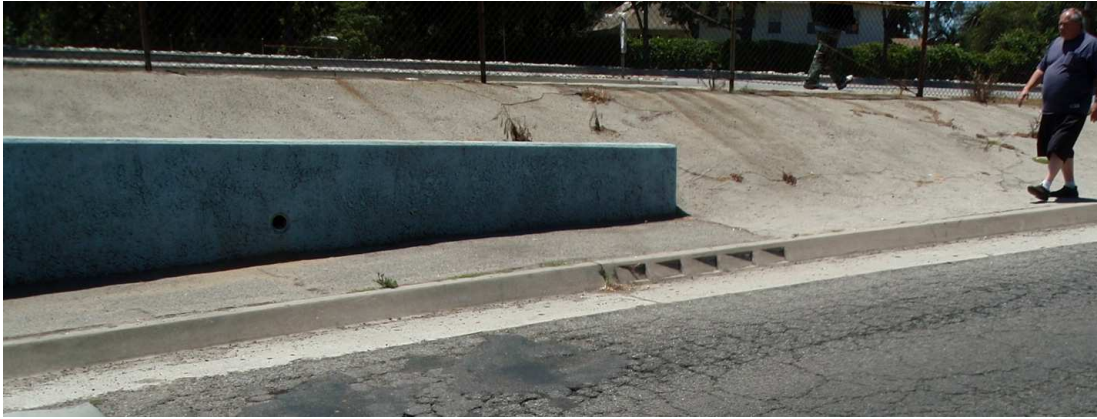
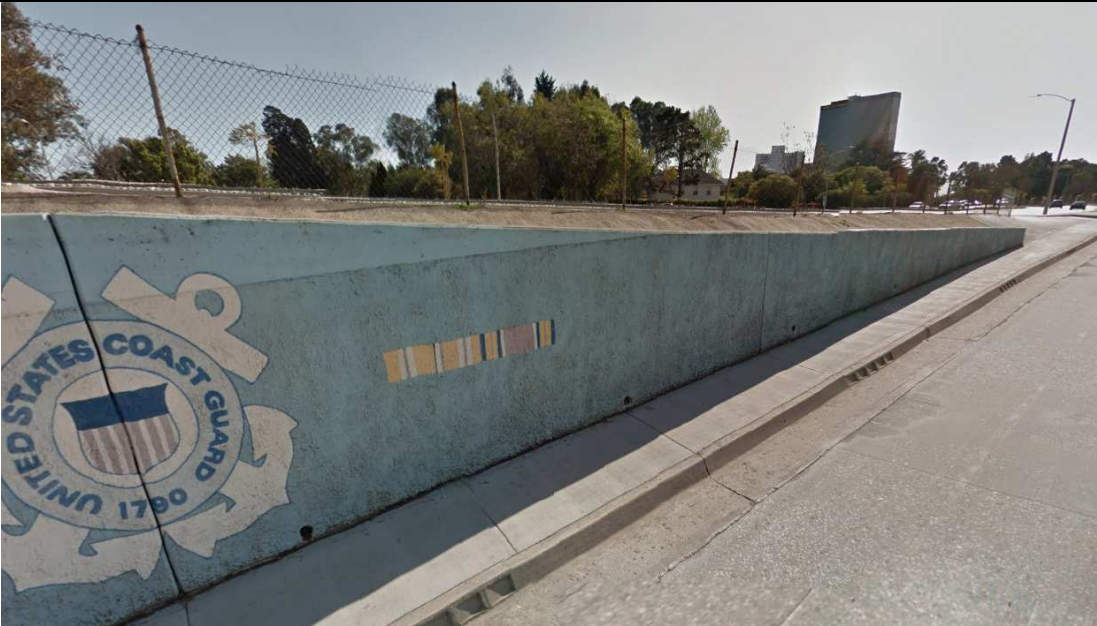
WILSHIRE BLVD WESTBOUND ON-RAMP:
Existing AC sidewalk was reconstructed with concrete

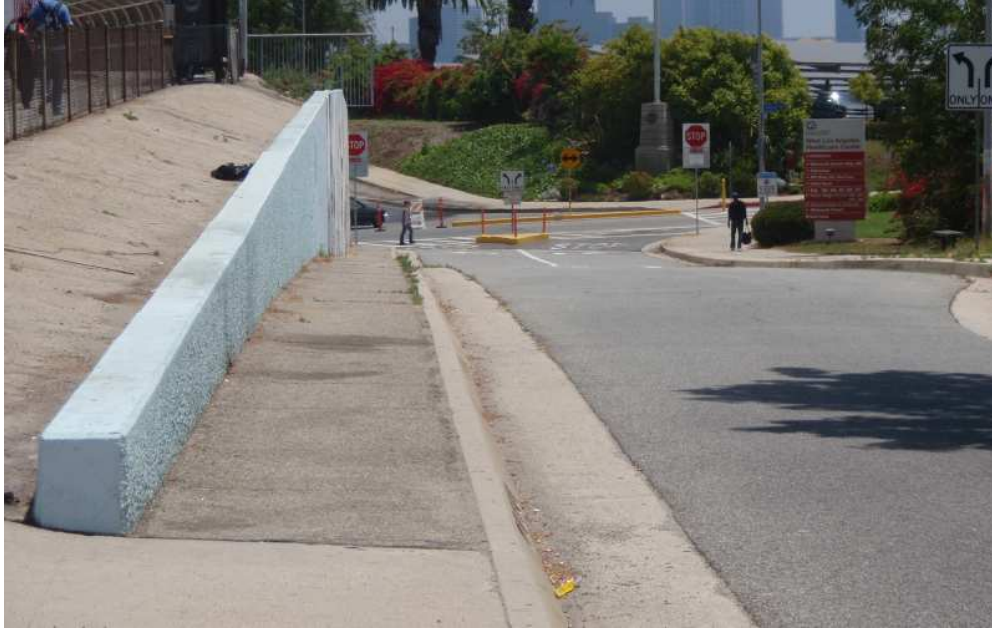
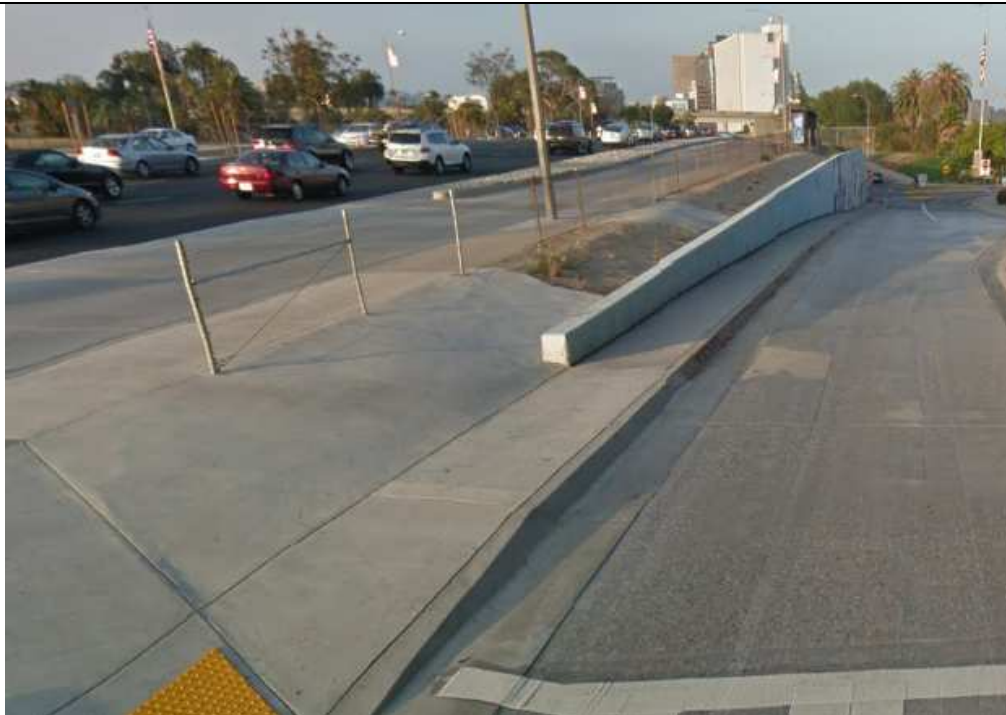
WILSHIRE BLVD EASTBOUND OFF-RAMP:

The existing AC sidewalk was reconstructed with concrete sidewalk.

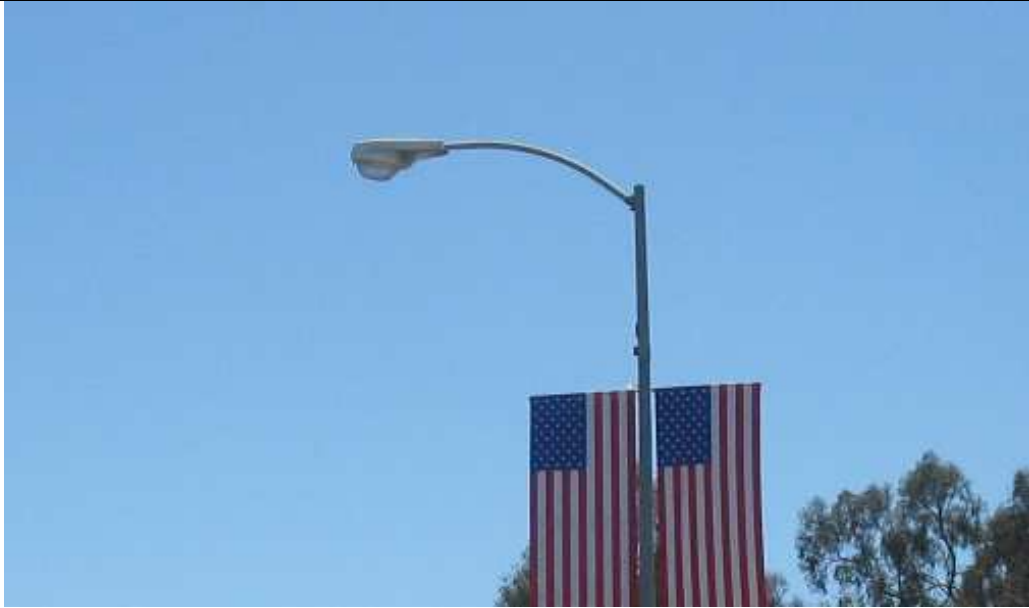
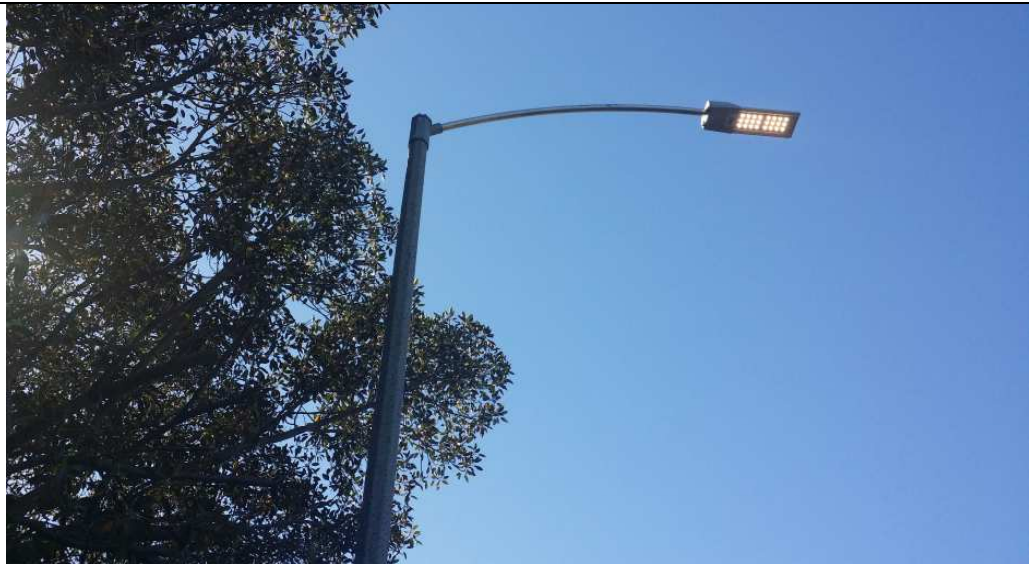
WILSHIRE BLVD:

The street lights were upgraded with Light Emitting Diode lights.

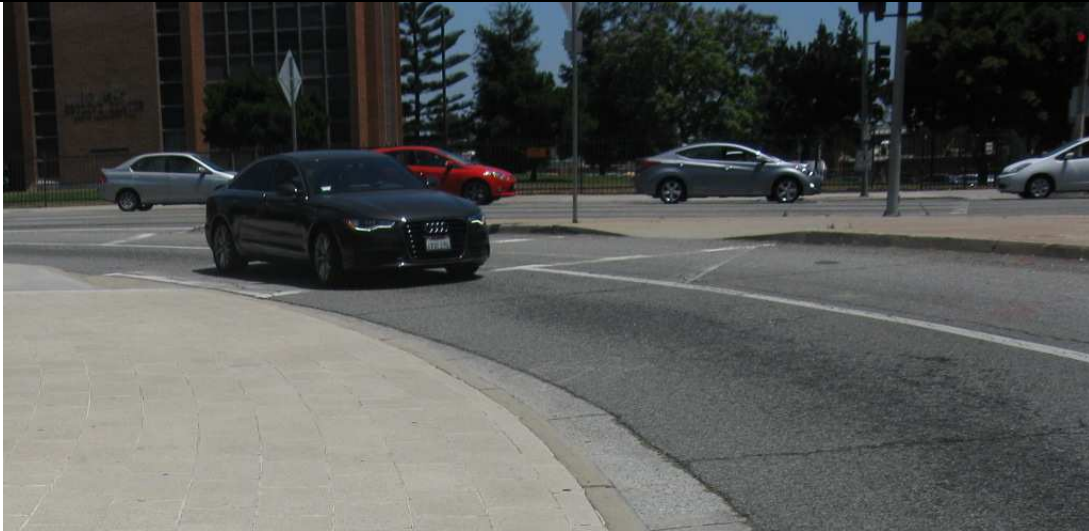
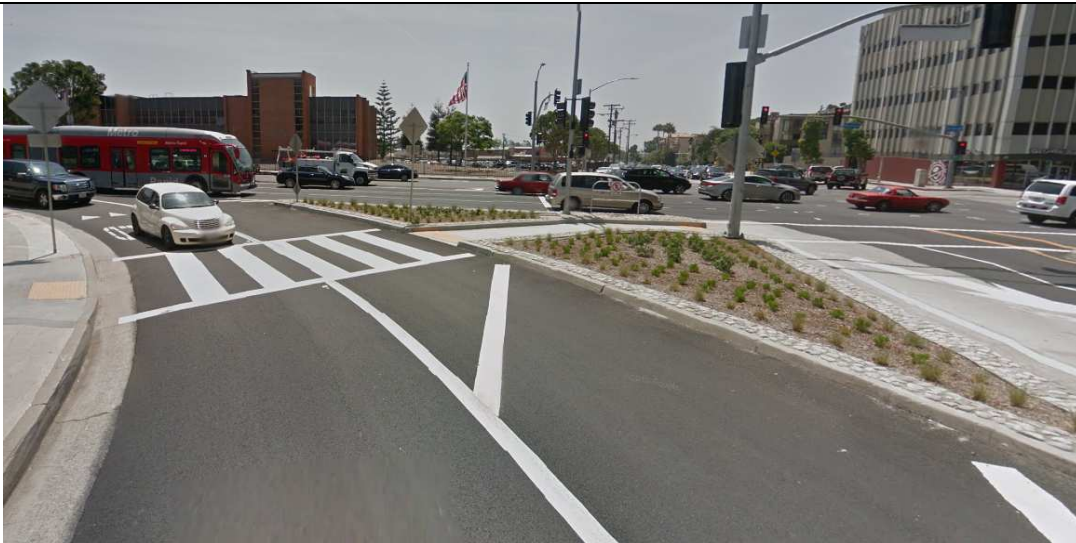
WILSHIRE BLVD AT SAN VICENTE BLVD TRAFFIC ISLAND:

Drought tolerant and California native plants were used to landscape the traffic island on both sides of the passageway to minimize water usage. Smart and efficient landscape irrigation systems and solar irrigation controllers were utilized.

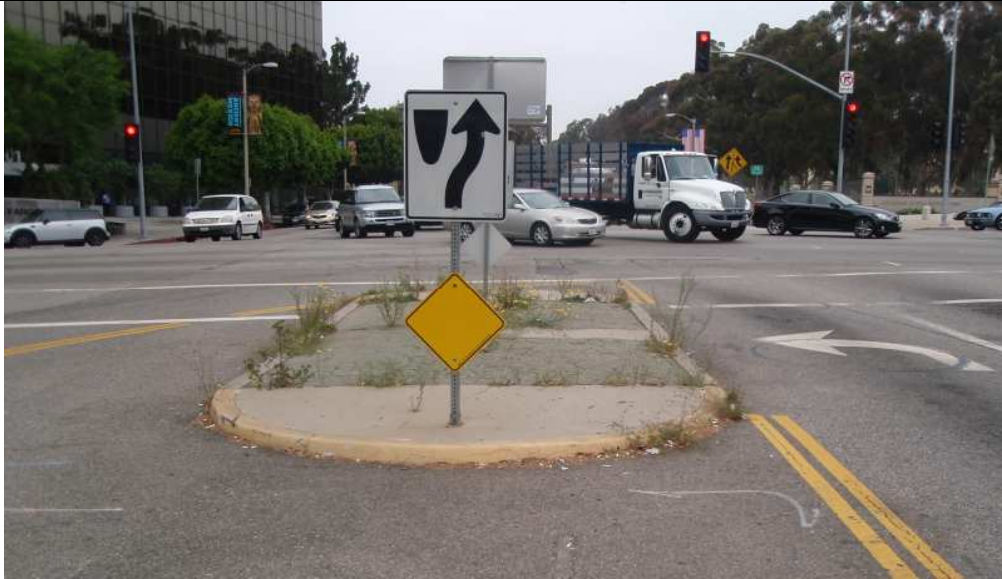
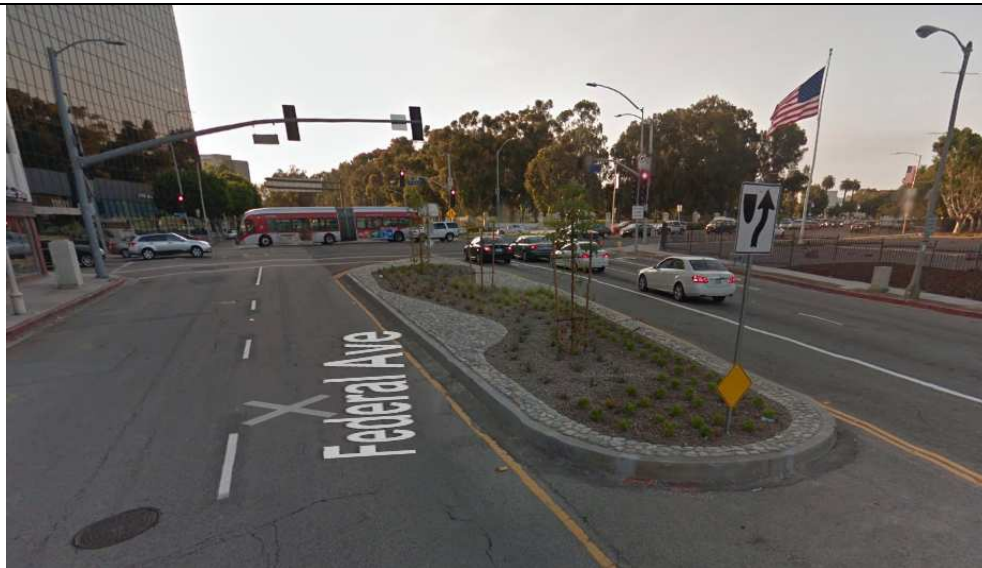
FEDERAL AVE MEDIAN:
California native/drought tolerant plants were planted within the median.

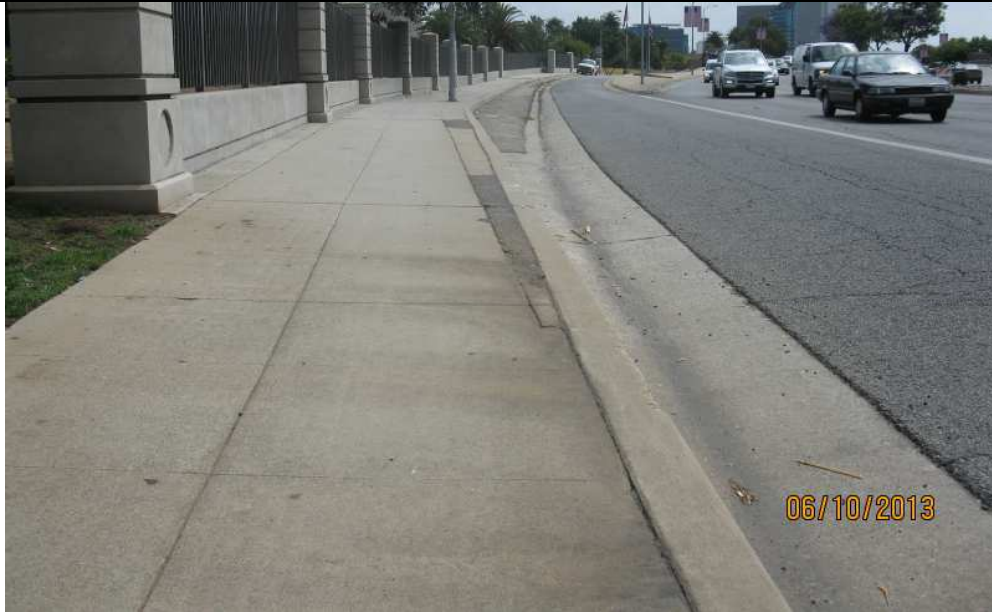
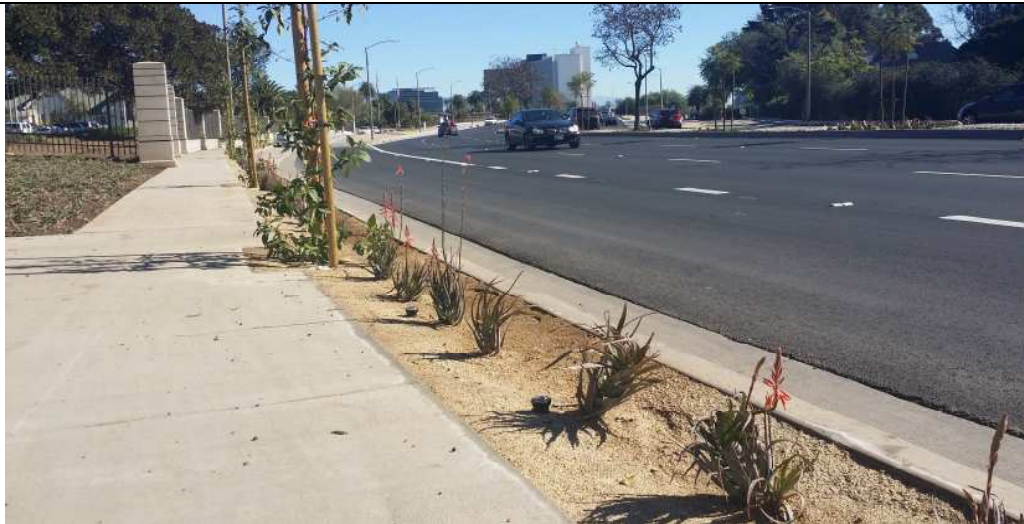
WILSHIRE BLVD NORTHERLY PARKWAY:

Parkway planting along the sidewalk created a buffer from the adjacent traffic for pedestrians. Decomposed granite was installed to facilitate more percolation of street runoff into the ground.

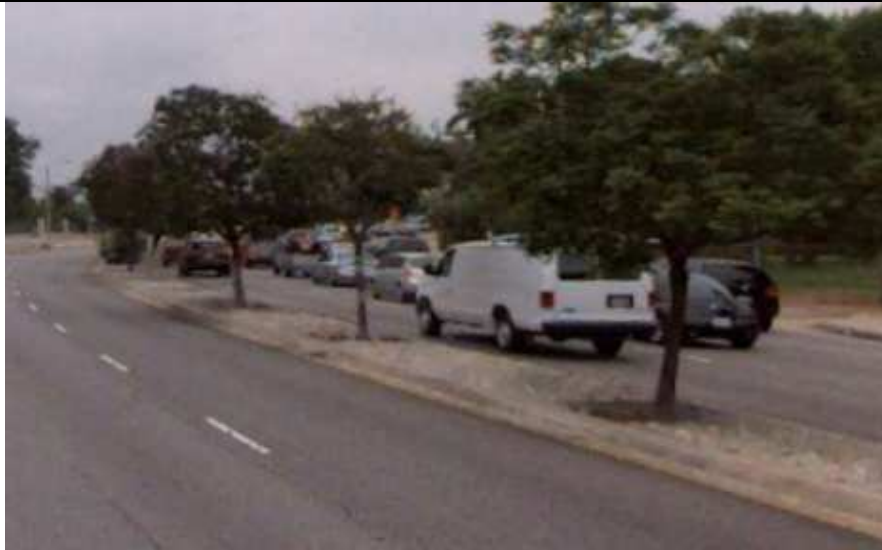
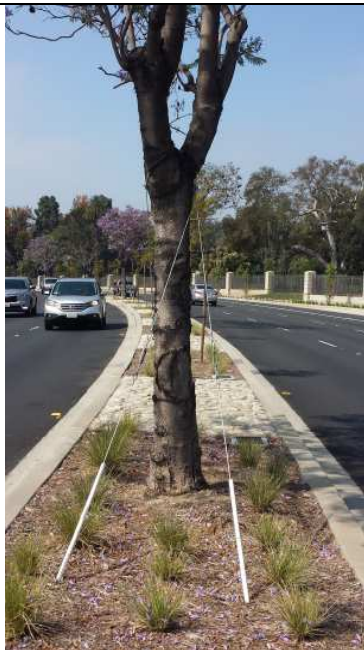
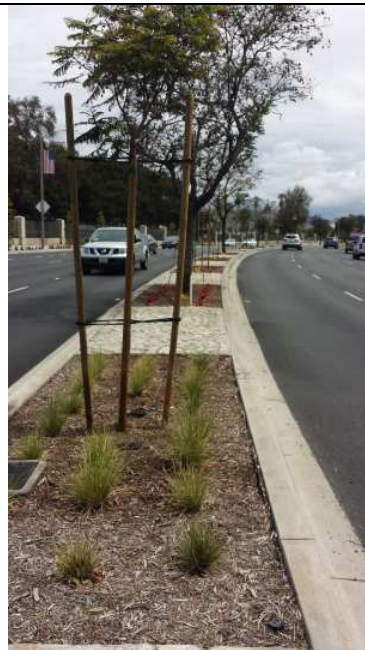
WILSHIRE BLVD MEDIAN:

During construction to widen the roadway and realign the median for the new peak hour bus lane, the healthy existing trees were saved and transplanted into the newly landscaped median.

(saved tree)

(new tree)
