Georgia Street Bridge Location

Georgia Street Timeline

Retrofit/Rehabilitation/Reconstruction

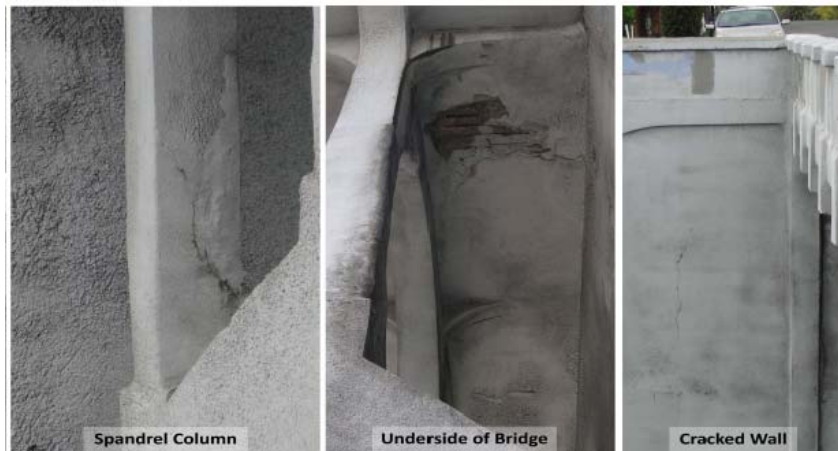
Existing Condition

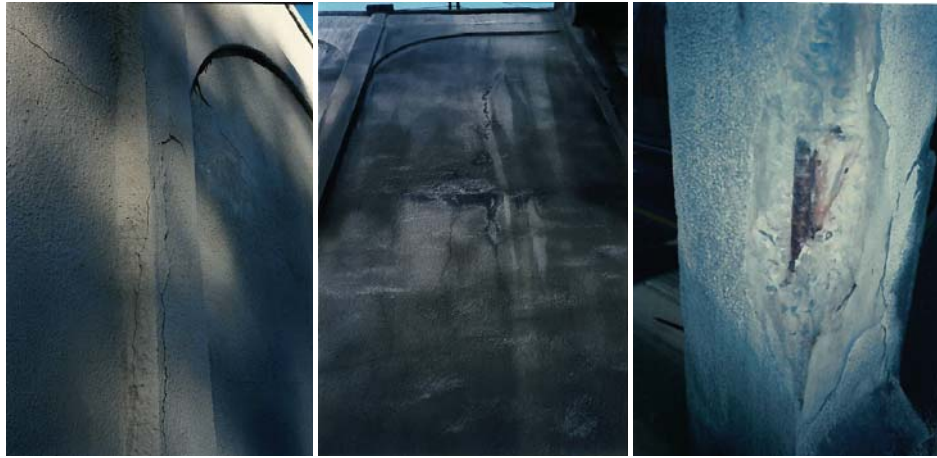
Existing Condition

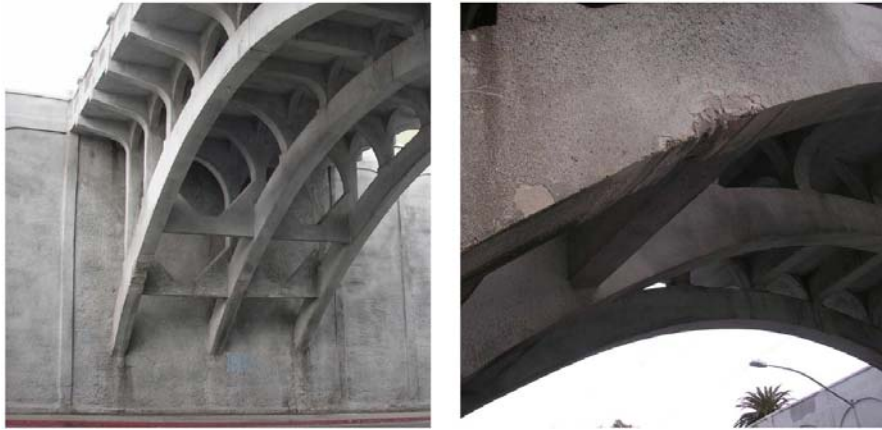
Existing Condition

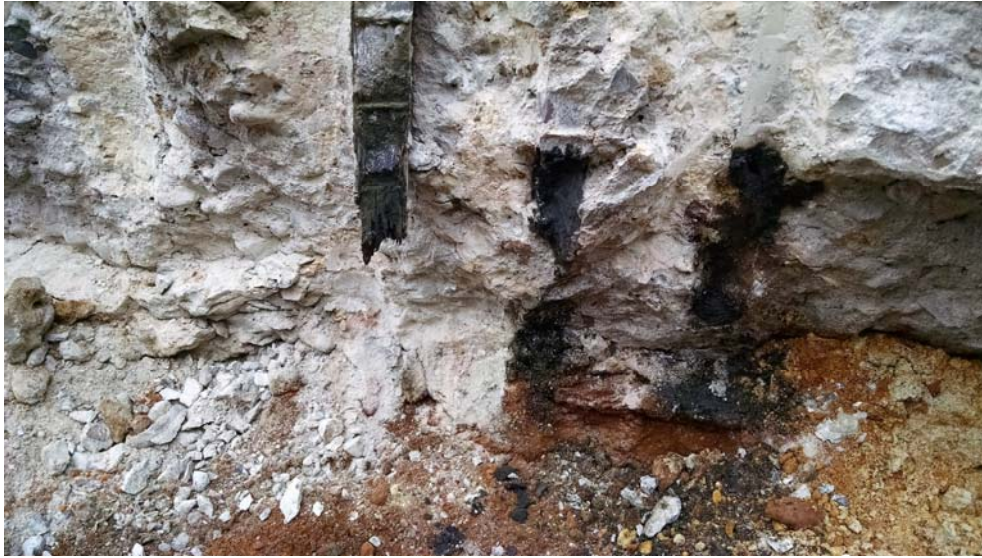
Existing Condition

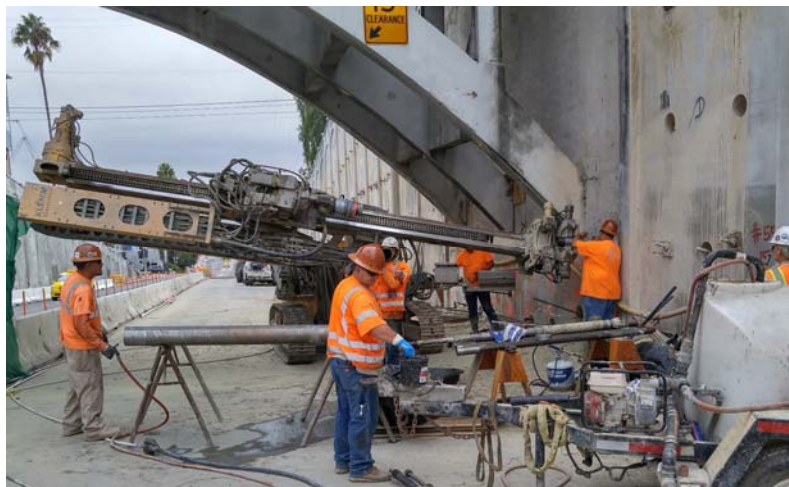
Soil Nail Installation Using Temporary Steel Casing

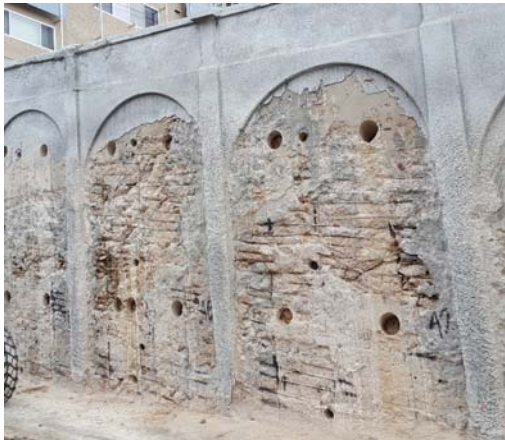
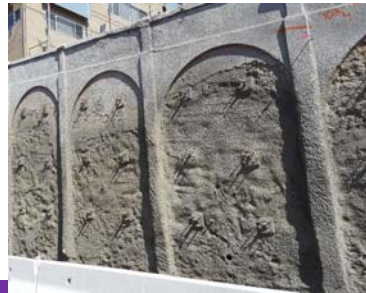
Reinforce and Shotcrete Wall Unsound Concrete

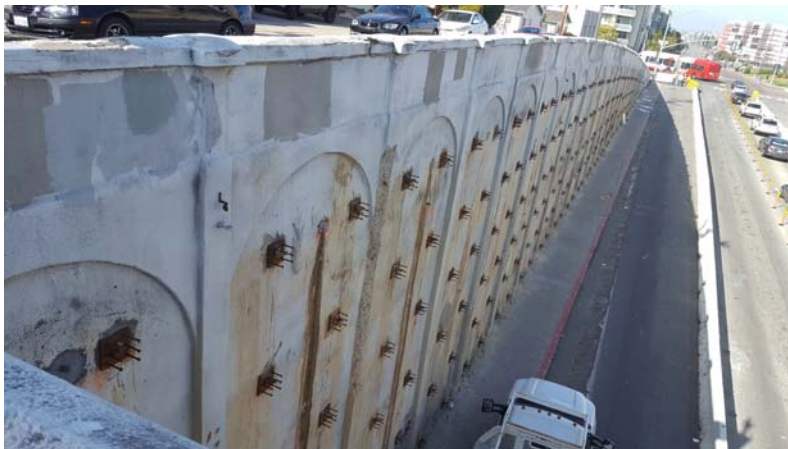
Existing Wall Curved Alignment

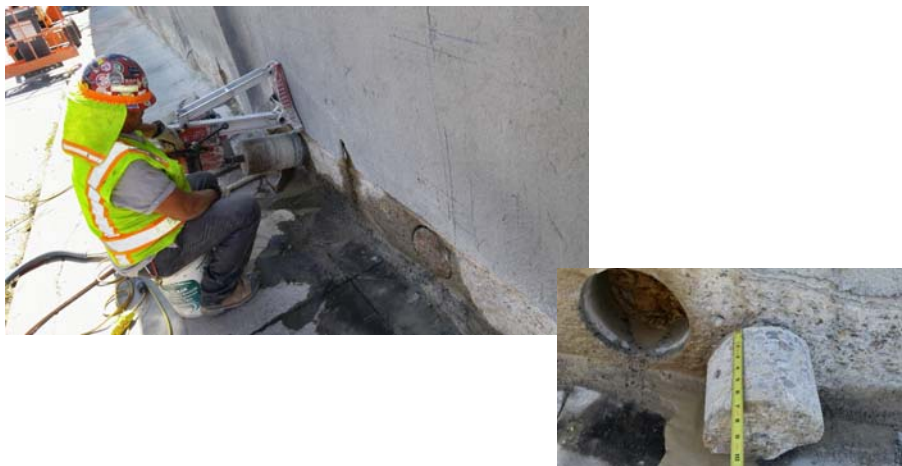
Coring Abutment and Retaining Walls

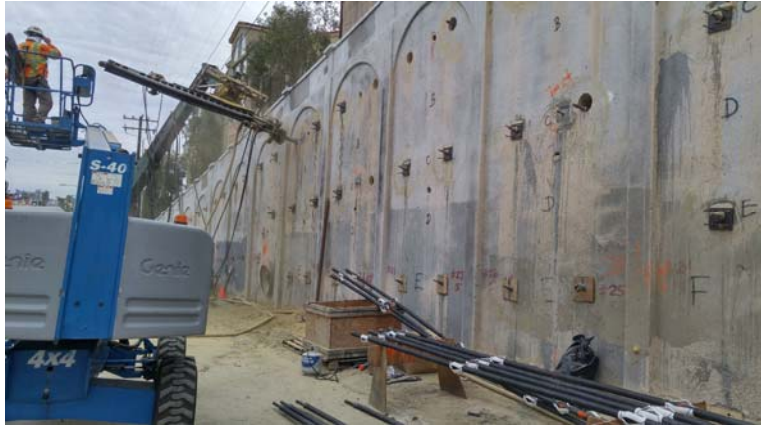
Drilling into Backfill and Formation

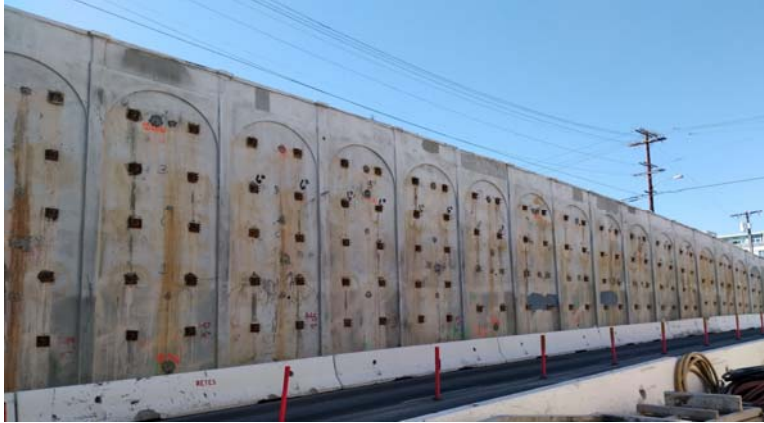
Soil Nails Installation Completed

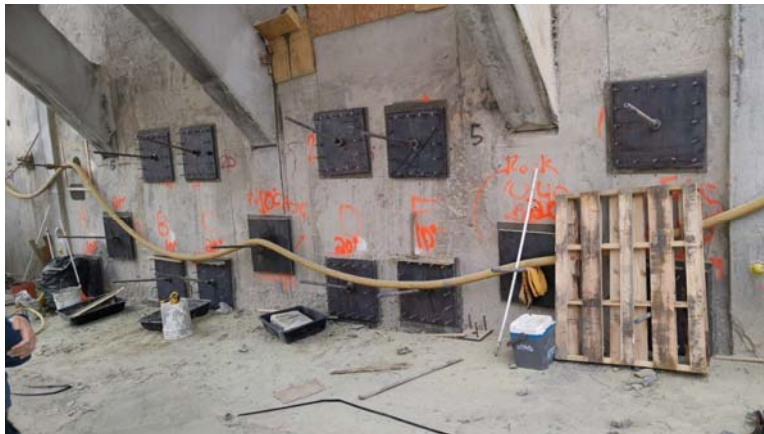
Ground Anchor Installation

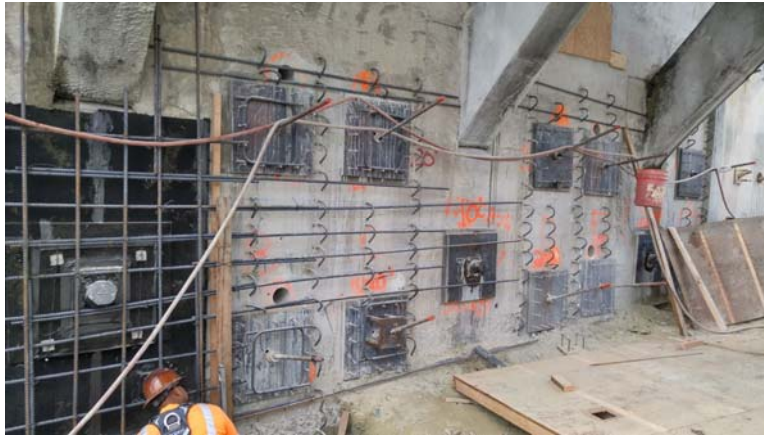
Abutment New Facing Construction

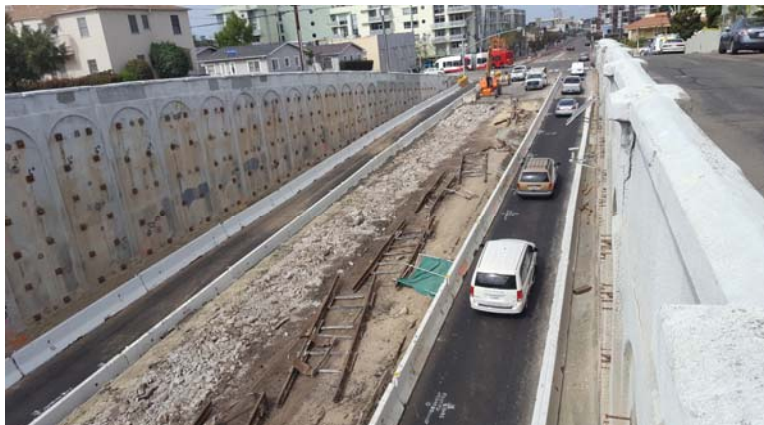
Roadway Lowering

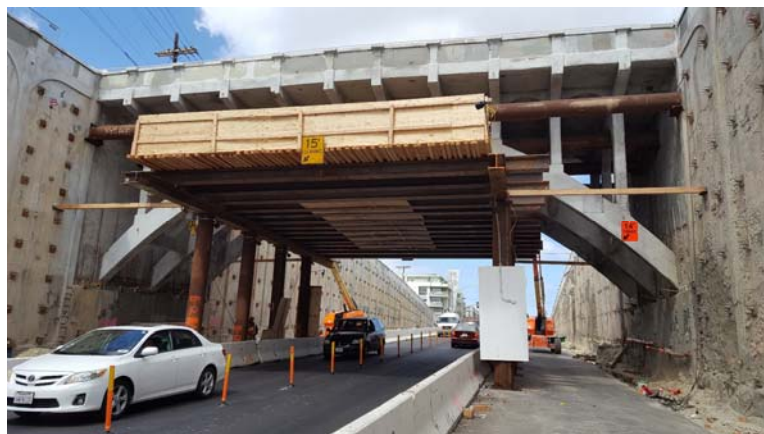
Traffic Protective Cover

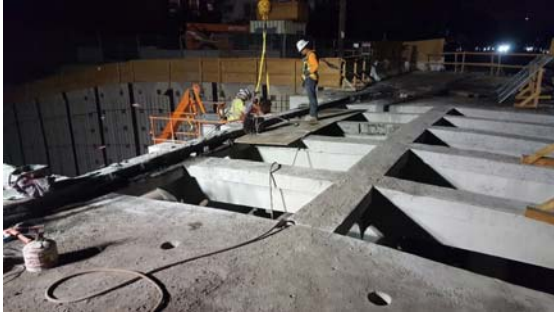
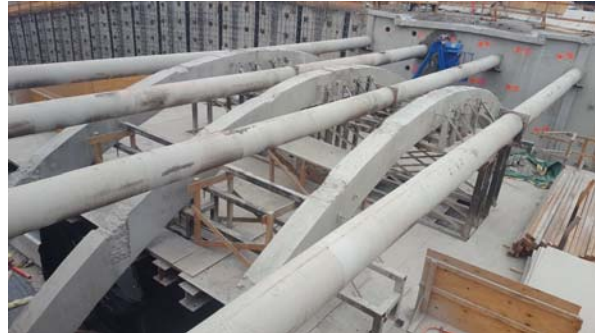
Bridge Demolition

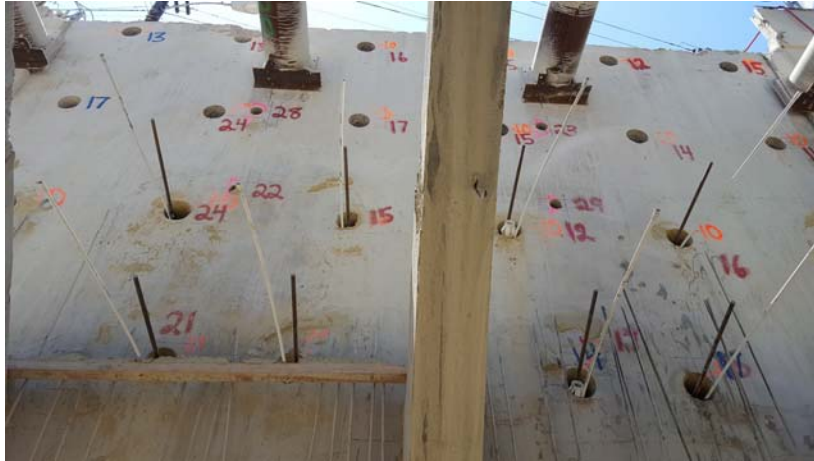
Installation of Remaining Ground Anchors

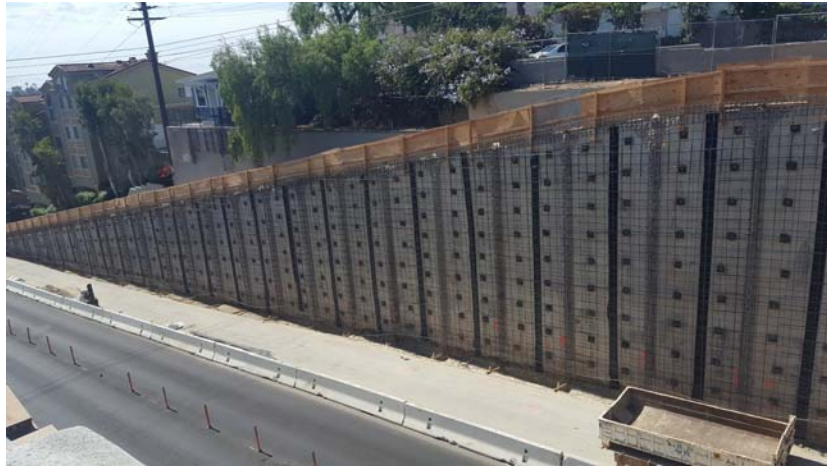
New Facing Construction

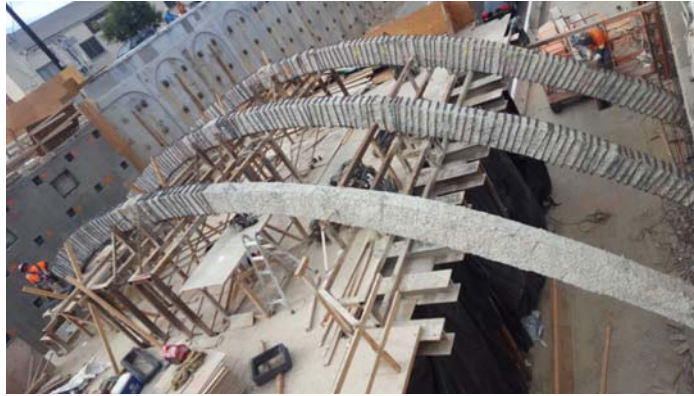
Arch Rib Retrofit

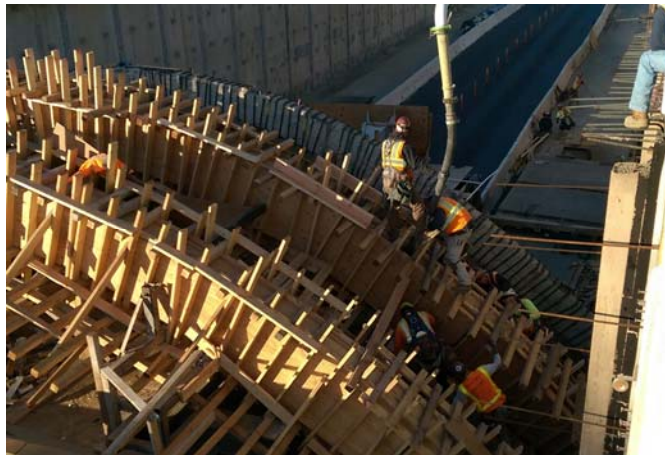
Arch Rib Retrofit

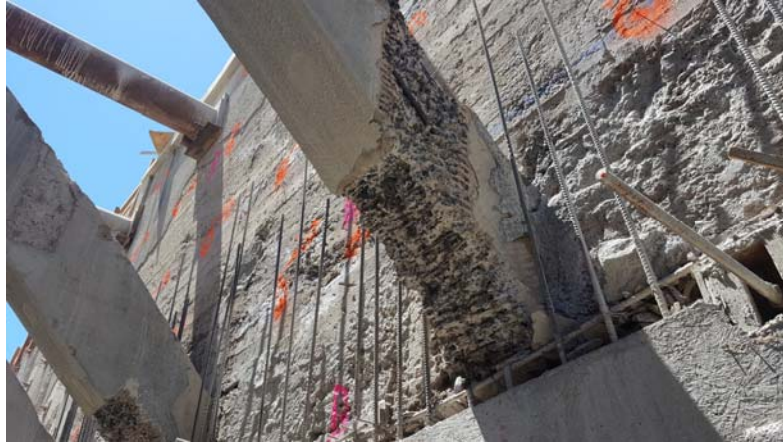
Hydrodemolition- Alternative Means and Method

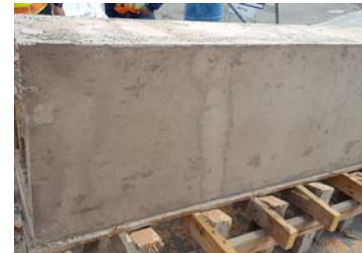
Arch Rib Fiber Reinforced Self-Consolidating Concrete

Arch Rib Mock-ups
