Marsh Creek Road Bridge Replacement Project

Contra Costa County

Public Works Department

January 11, 2019

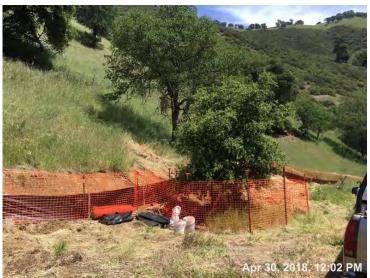
To limit exposure to wildlife within the jobsite, the Contract essentially called for TWEF to provide a buffer at the edges of the jobsite. The TWEF called for in this project was the standard Caltrans TWEF, which consisted of silt fence and orange ESA fencing. In addition to TWEF fence, dripline fencing was provided around tree driplines to ensure their roots were not damaged by heavy equipment.

- > To limit exposure to wildlife within the jobsite, the team installed Temporary Wildlife Exclusion Fencing (TWEF) to provide a buffer at the edges of the jobsite, and dripline fencing around trees to ensure their roots were not damaged by heavy equipment.

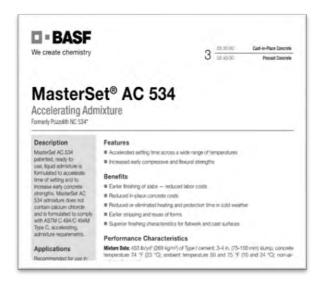
High-Early Strength Mix Designs - The project team approved two special concrete mix designs, one with higher cement content and water reducers (Delvo), and another with concrete accelerant BASF MasterSet AC 534, which is pre-approved through Caltrans. By using one of these mixes in the abutment pours, retaining walls and approach slabs, the contractor was able to cut off several days from the project. They were able to backfill sooner in the case of abutments and retaining walls, and were also able to drive on the approach slabs sooner, as strength came up in 3 days, rather than 7 days. That's over 4,200 psi concrete in 3 days!

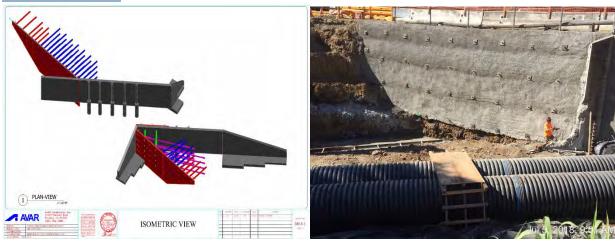
The final solution was a partial soil nail wall, and partial sub-horizontal ground anchor, part of which engaged the existing bridge through a waler system that spread the load to the vertical pile/columns. This solution allow the Contractor to perform a partial demo, protect the 6" bypass water line and build the Stage 2 – Bridge Substructure and Superstructure all while stabilizing the directly adjacent roadway serving 6,000 vehicles a day. Finally, it served as a form for the Soil-Cement MSE wall that was construction in Stage 2, which facilitated Stage 4 Bridge Construction.

One of the most critical requirements for project success was for the contractor to figure out a shoring solution that would allow for stage construction. The existing Marsh Creek Bridge abutment was unique it that is served more as a bulkhead, rather than as an abutment. As such it was very nominally reinforced. Through a repeated review process, the Construction Manager, the County, and the Contractor were satisfied with the solution.

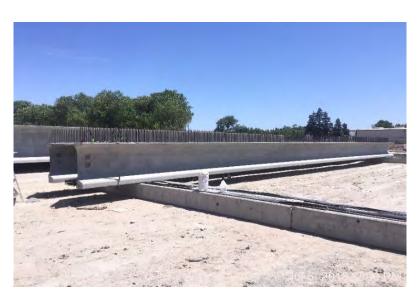
The six 88'3" long girders were fabricated in Lathrop, California at Confab LLC. The fabrication was Source Inspected and the Quality Assurance was performed by BSK Associates, who was part of the CM team.

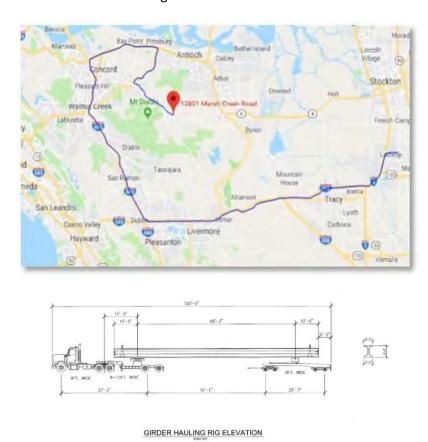
The RE and the Contractor and his subs (including his truckers) had an early logistics meeting part of the submittal requirements. The RE asked to provide information about the truck route to ensure safe delivery on a P-9 truck route. The following truck route was used:

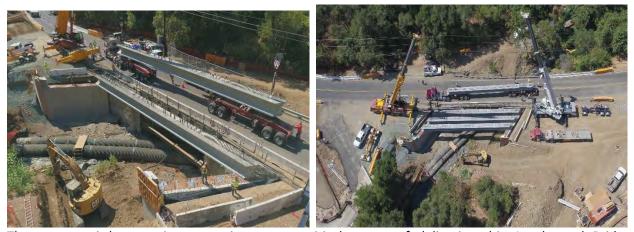
Stage 2 Girder Erection: Once delivered to the site, the girders were erected at two difference Stages. Stage 2 Girders were placed on August 2nd, 2018.

The precast girder erection operation was a critical aspect of delivering this Accelerated Bridge Construction (ABC) project in one construction season. The four 44-ton California Bulb-Tee girders were placed in only 3 hours by utilizing two 265-ton telescoping cranes, limiting exposure and delays to the traveling public.
