## **Bowman Road Bridges Replacement Project County of Placer Auburn, California**

The Bowman Road Bridges Replacement Project involved the improvement of two existing bridges (see Figures 1 and 2) located on Bowman Road in Auburn, CA. Both are three-span cast-in-place concrete tee-beam bridges built in 1949 and are both 154-feet in length. At the time of project initiation both bridges were categorized as Structurally Deficient and Functionally Obsolete based on their inspected condition (See Figure 3).

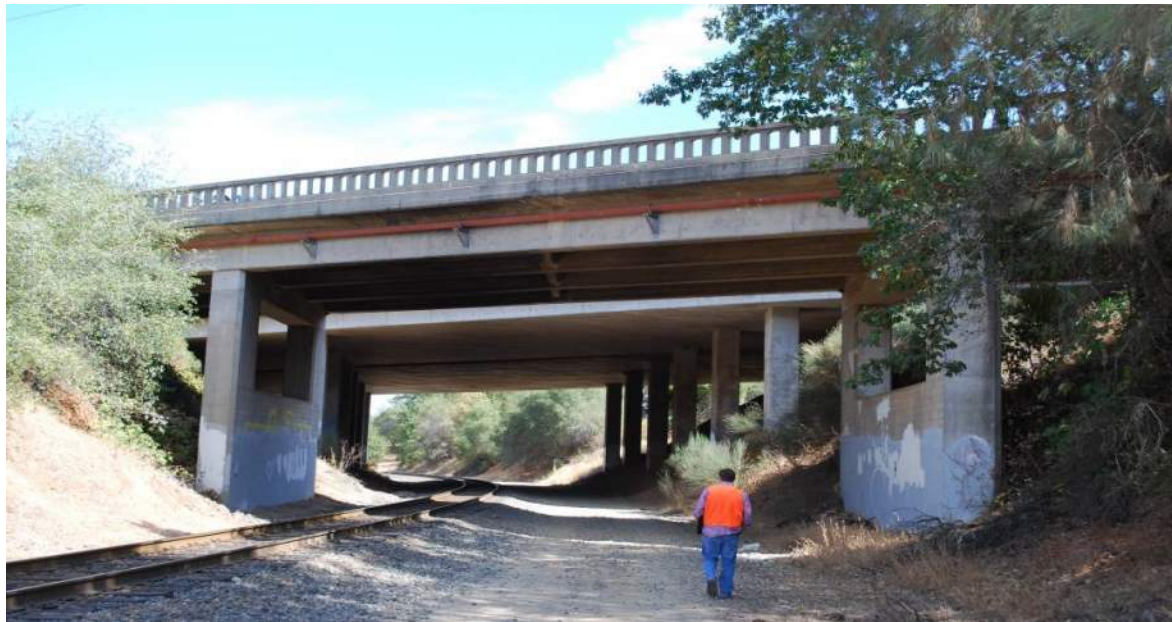
**Figure 1. South Bridge (19C-0061)**

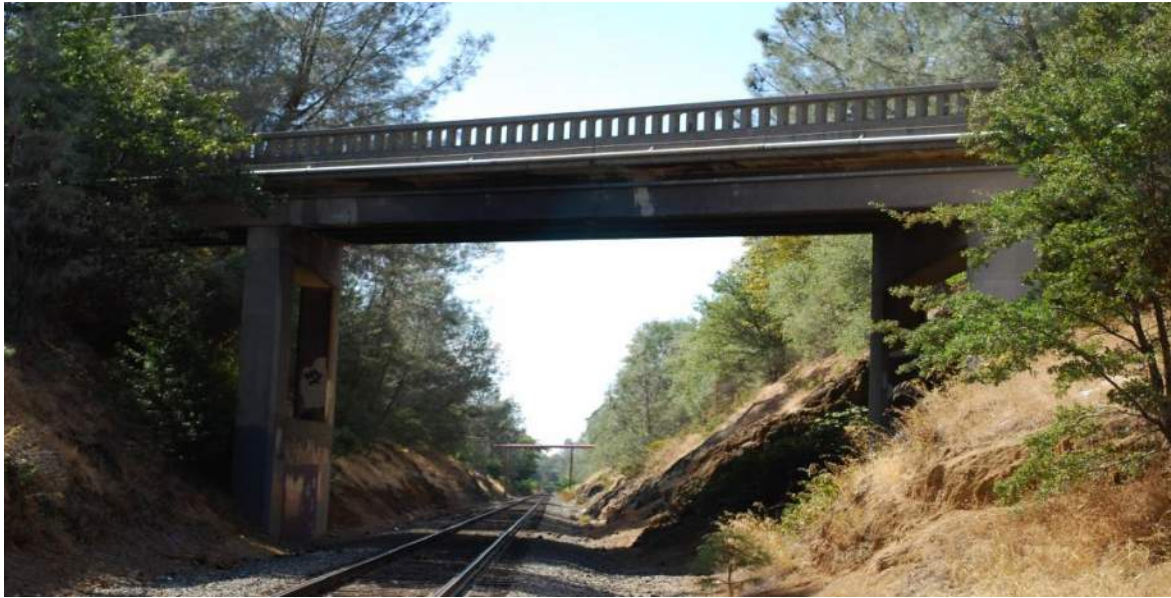
Figure 2. North Bridge (19C-0062)

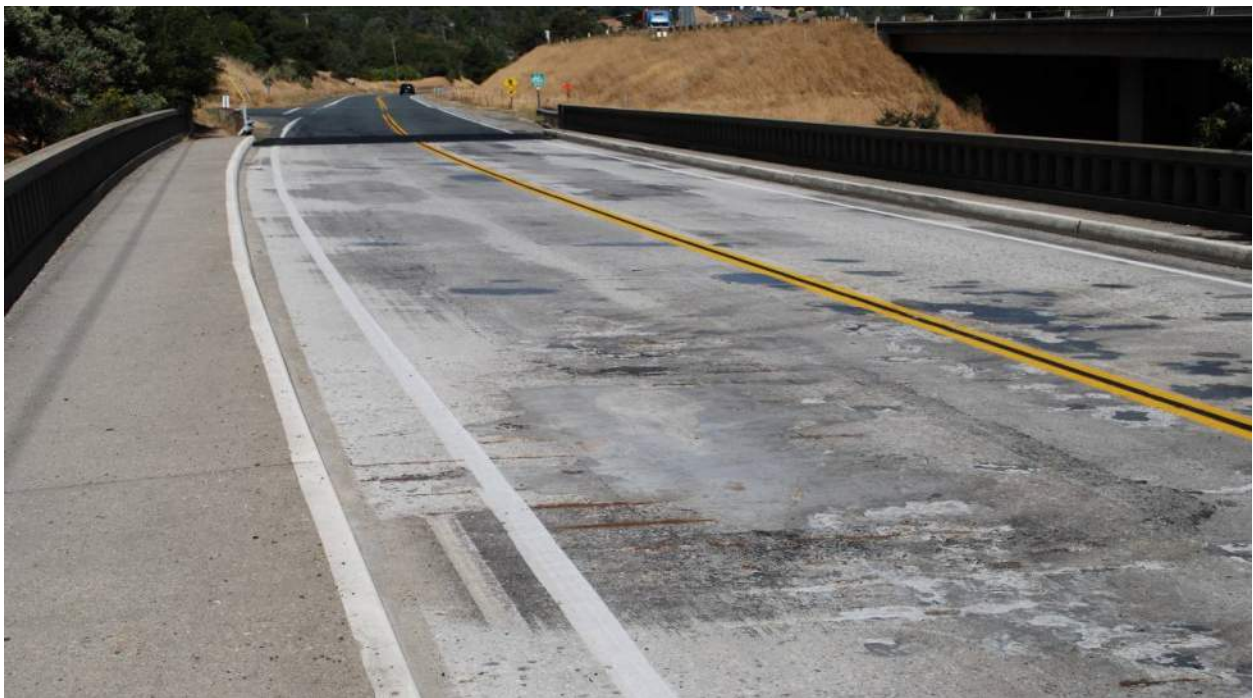
Figure 3. Deck Deterioration before Project

The existing deck had areas of delamination, spalling, and exposed corroding reinforcing. The work to correct this included spot repair of the spalled and delaminated areas (Figure 12), replacement of the overhangs (including barriers), and the application of a  $\frac{3}{4}$ " minimum thickness polyester concrete overlay (Figure 13).

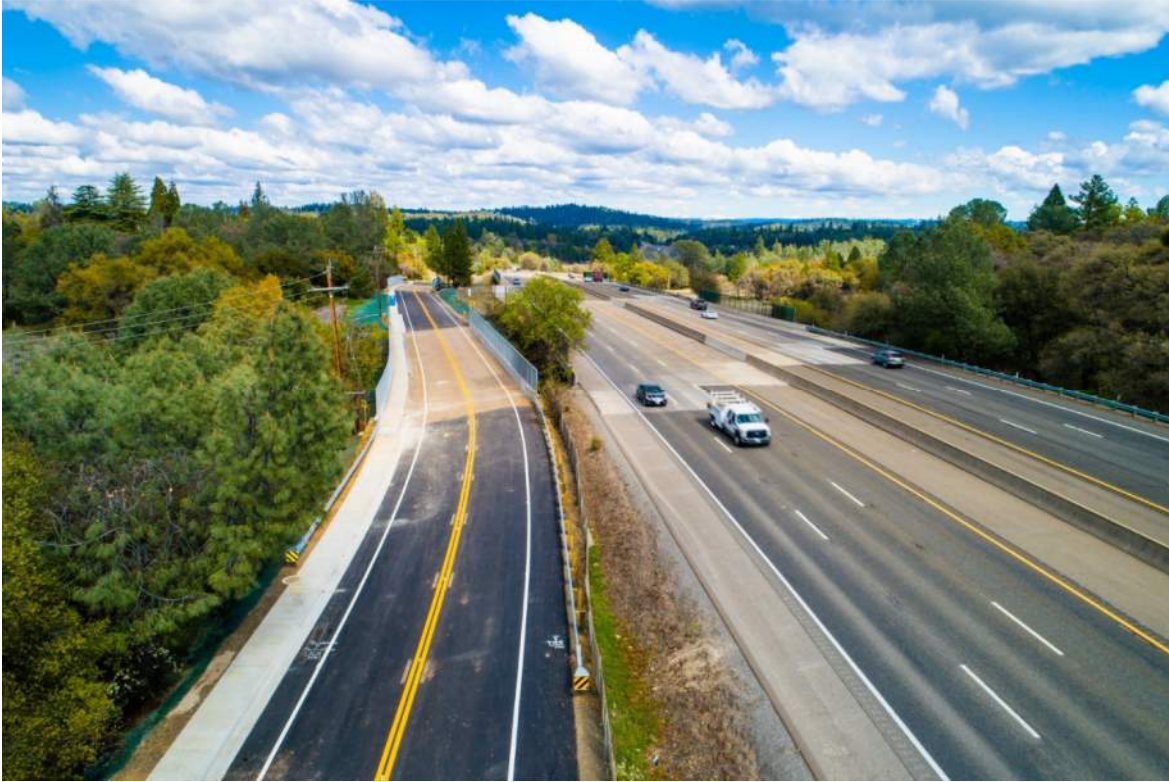
**Figure 5. Finished Project Overview**

Construction of the project was awarded in January 2019 with a low bid of \$3.5M. Construction commenced in March 2019 and was completed in March 2020, see Figures 5 and 6 for the finished project and detailed discussion of the final details and construction work below.

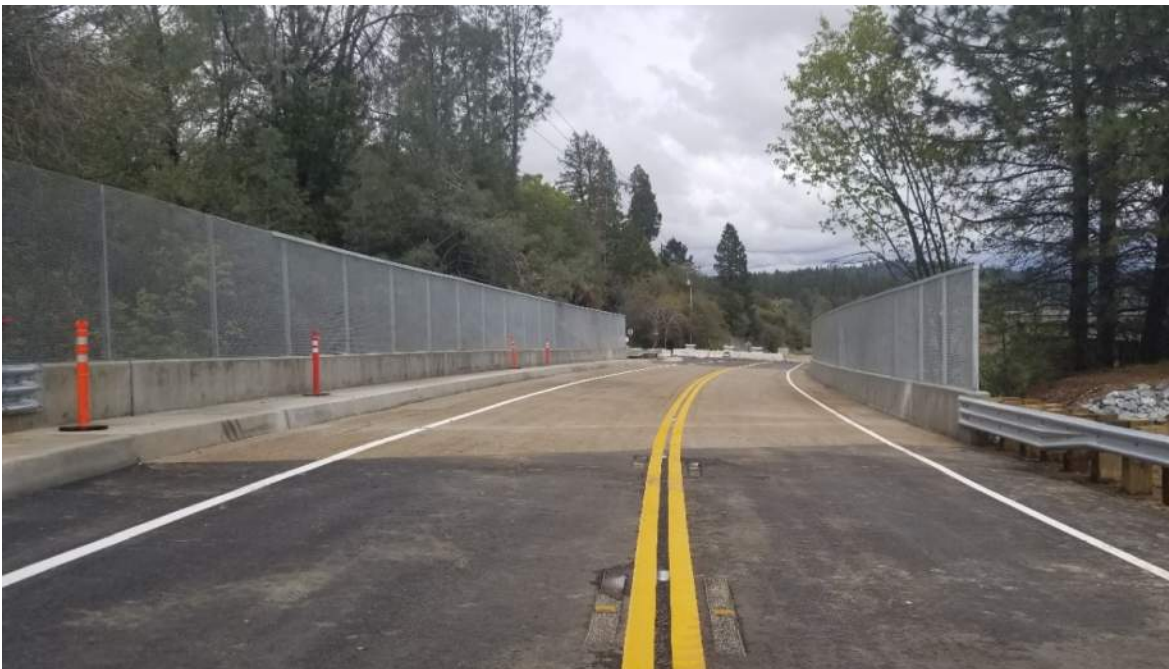
**Figure 6. Finished North Bridge (looking north)**

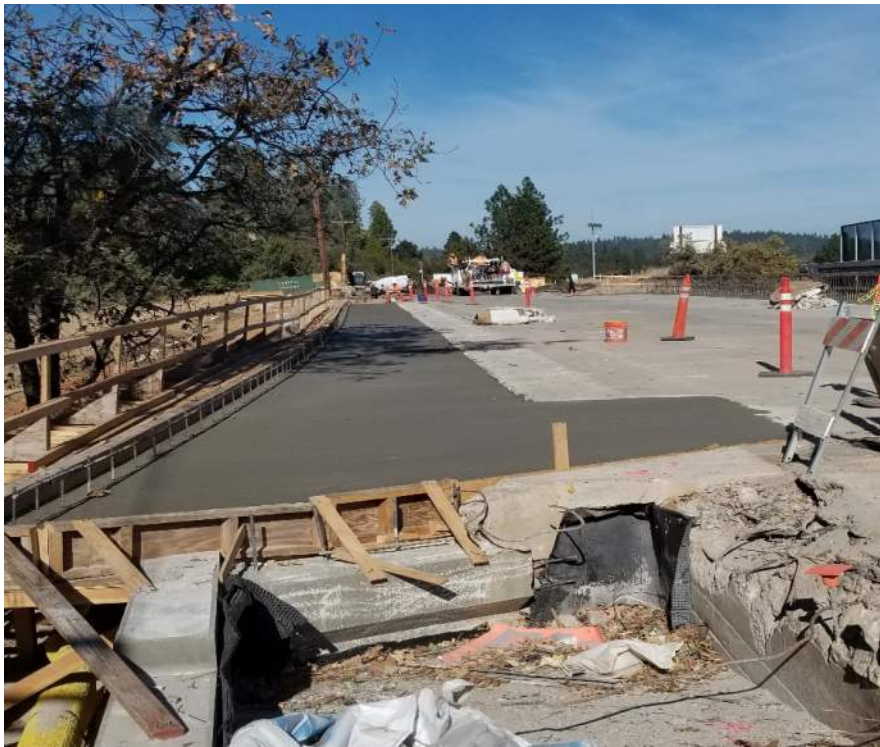
The original roadway alignment had sub-standard features at the south end of the south bridge, one of which was an angle point in the horizontal alignment, which limited the design speed. To provide the desired 45-mph design speed and accommodate the widening a horizontal curve was added to the south bridge approach. The addition of the horizontal curve necessitated widening the bridge with an additional girder to flare the bridge deck at this end (Figure 7). The additional girder required a column widening and abutment widening. The pile supported abutment was widened using micropiles (Figure 8). This novel solution was devised to accommodate construction with the tight space constraints, subsurface conditions, and presence of utilities under the abutment, while being cost-effective.

Figure 7. South Bridge Widening – Flared Deck at Added Girder

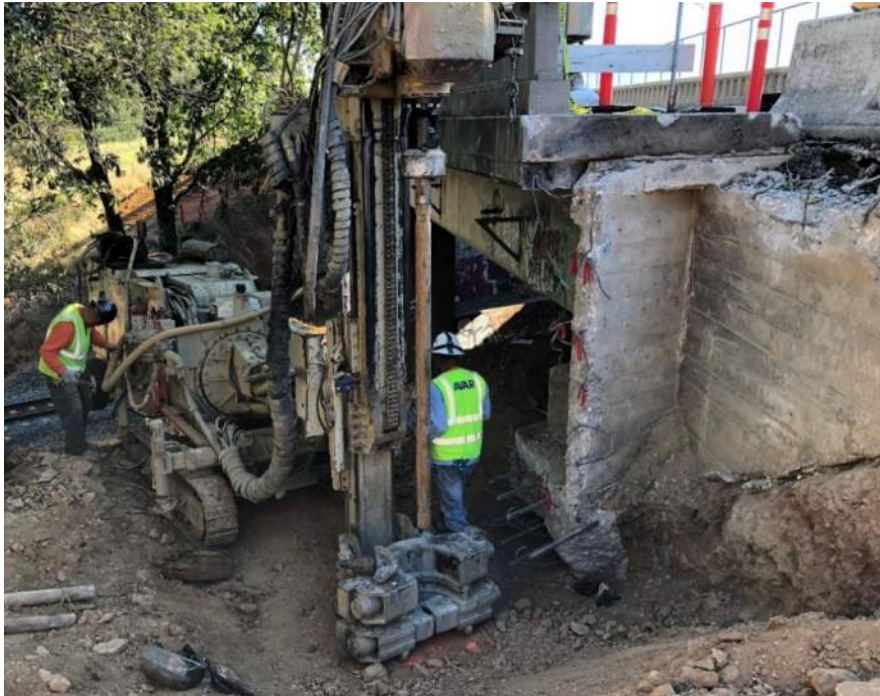
**Figure 8. South Bridge Widening – Micropile Installation at Abutment Widening**

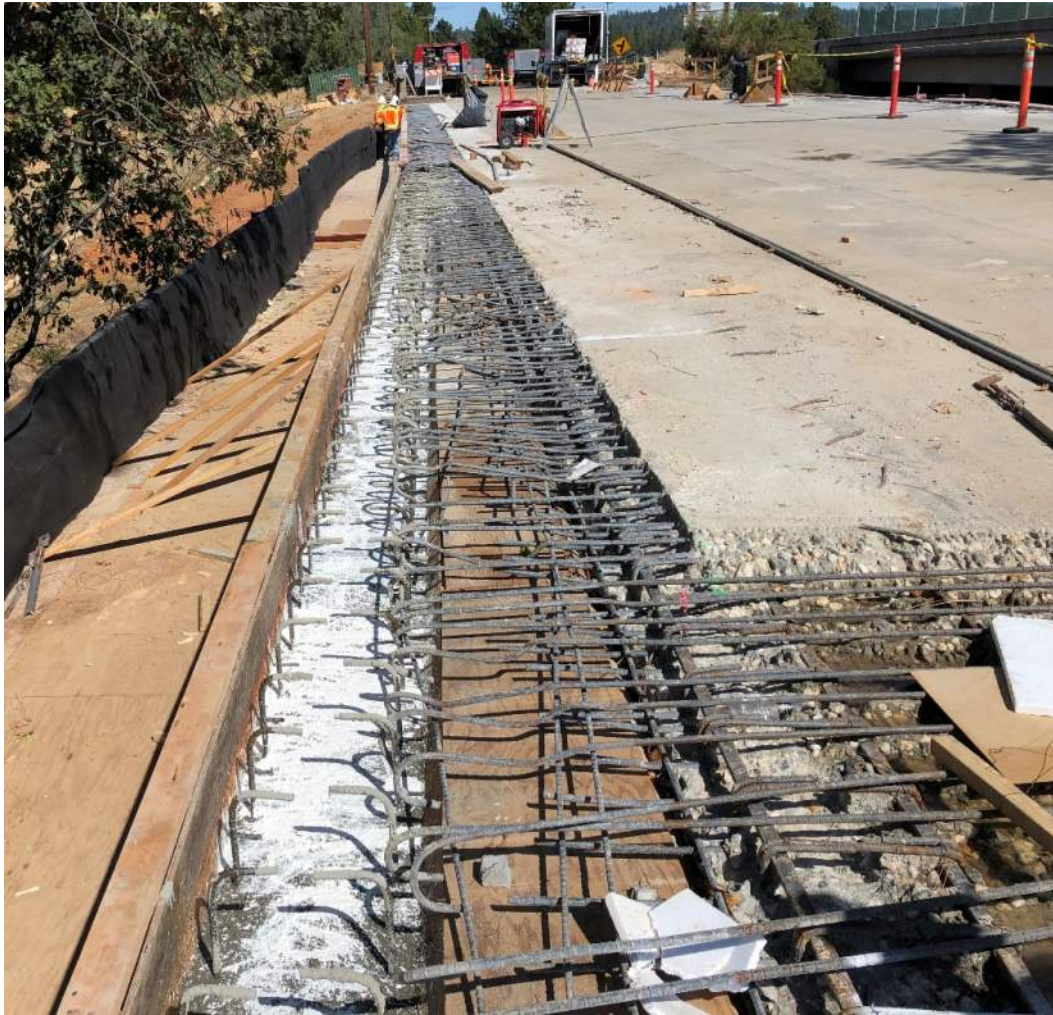
**Figure 9. South Bridge Widening – Staged Deck and Overhang Replacement (beyond) and New Girder (foreground)**

The partial deck and overhang replacement work required careful staging to prevent overstressing girders during construction. Part of the existing deck had to be removed so that the new overhangs could be constructed. This removal temporarily reduced the strength of the girders. Instead of shoring under the girders, which would have conflicted with the UPRR tracks, a staged construction scheme was designed that allowed the girders to be self-supporting but with tight controls in place on how much could be removed at a time. Additionally, protective covers were provided over the UPRR right-of-way throughout the overhang demolition and reconstruction which allowed more continuous operations improving work efficiency.

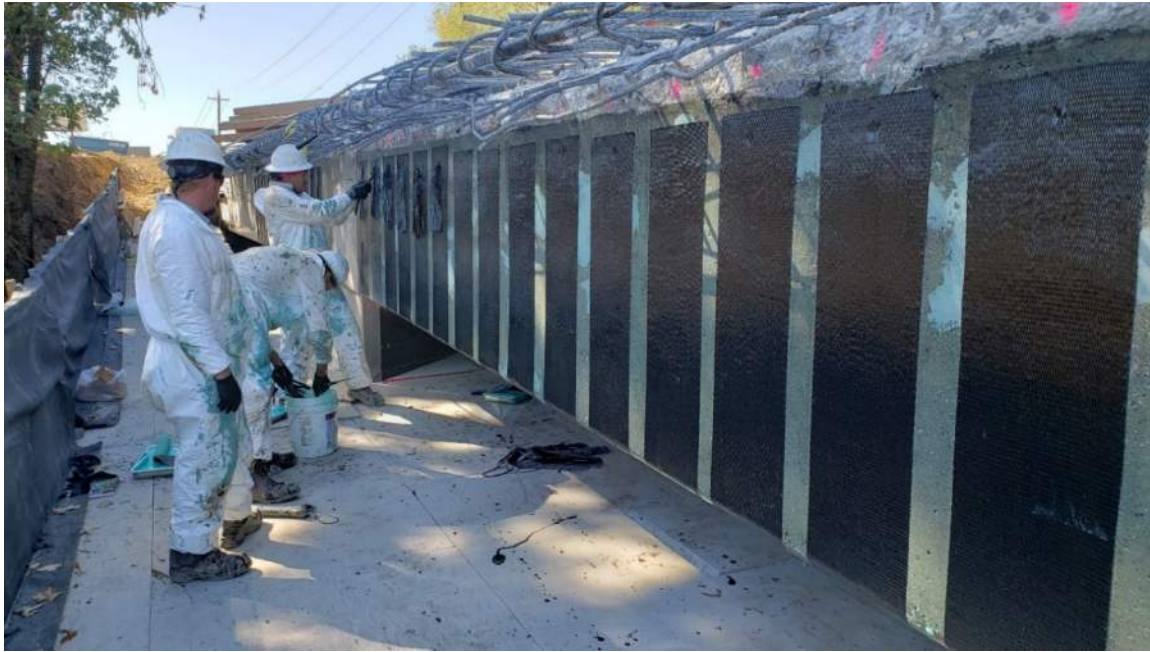
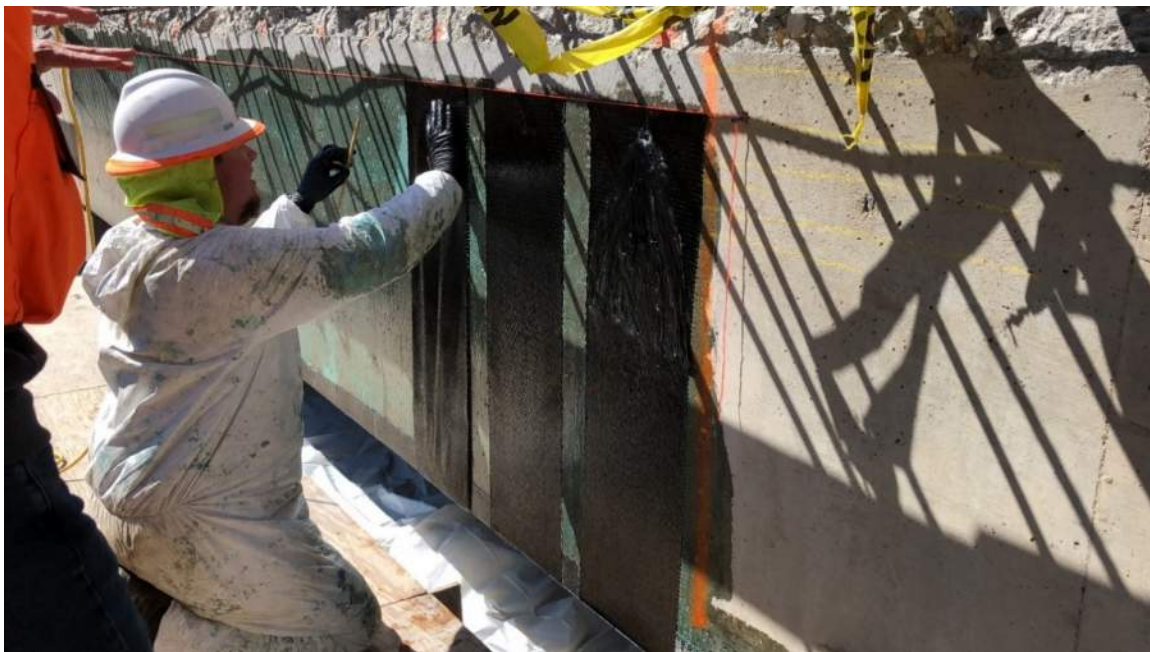
**Figure 10. Girder Strengthening – Installation of CFRP Shear Stirrups with Anchors**

**Figure 11. Girder Strengthening – Installation of CFRP Shear Stirrups with Anchors**

The widening of the bridge resulted in increased live load demands to the exterior girders. This was mitigated with strengthening using a Carbon Fiber Reinforced Polymer (CFRP) system. This system consisted of externally applied CFRP strips (Figure 10 & 11) applied to the girders to strengthen for shear and positive moment. The added strengthening allowed the bridges to maintain full HS-20 truck and California permit truck load capacity. The rarely used method of strengthening was highly effective and proved to be an efficient and cost-effective means of increasing girder strength.

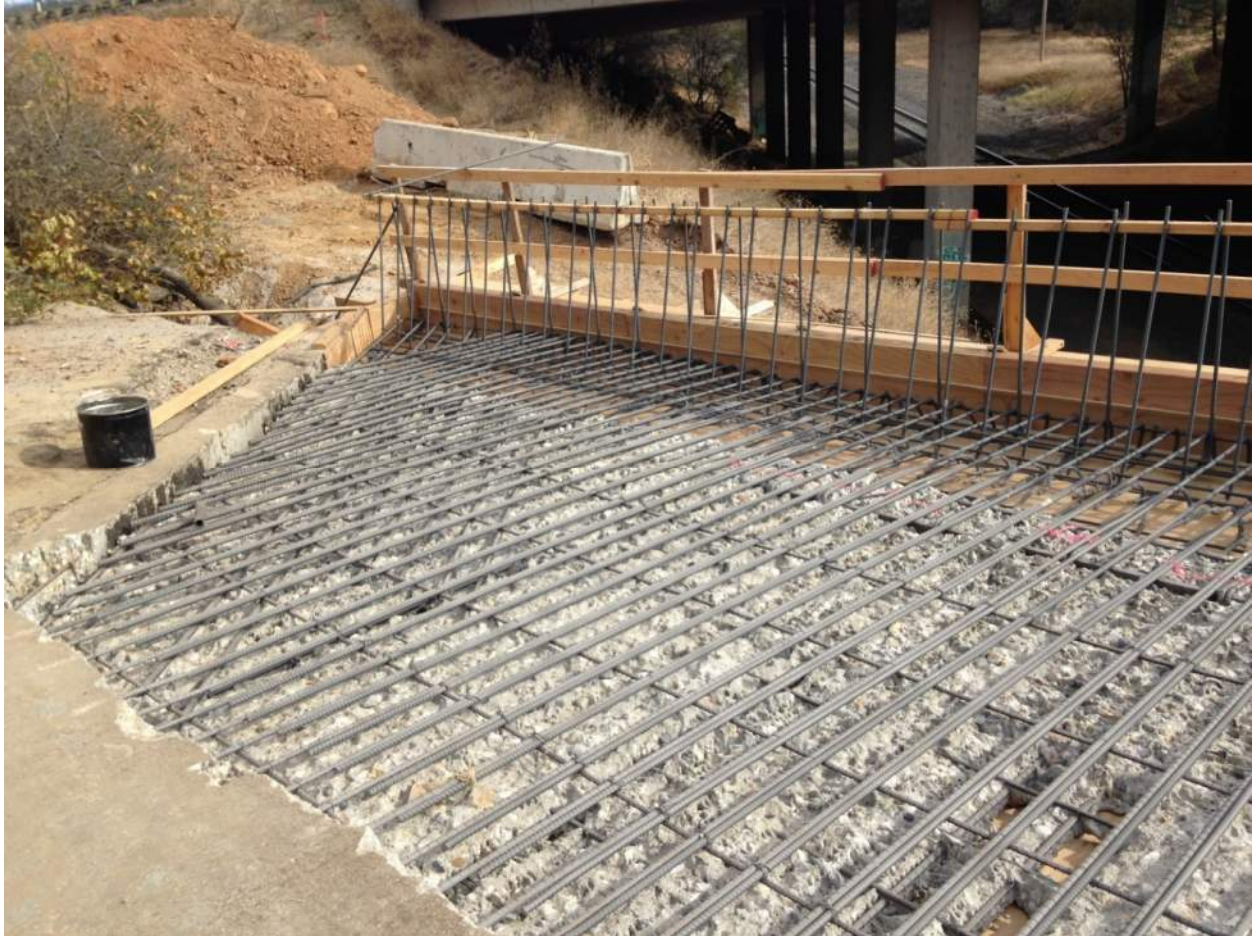
Figure 12. Overhang and Partial Deck Replacement

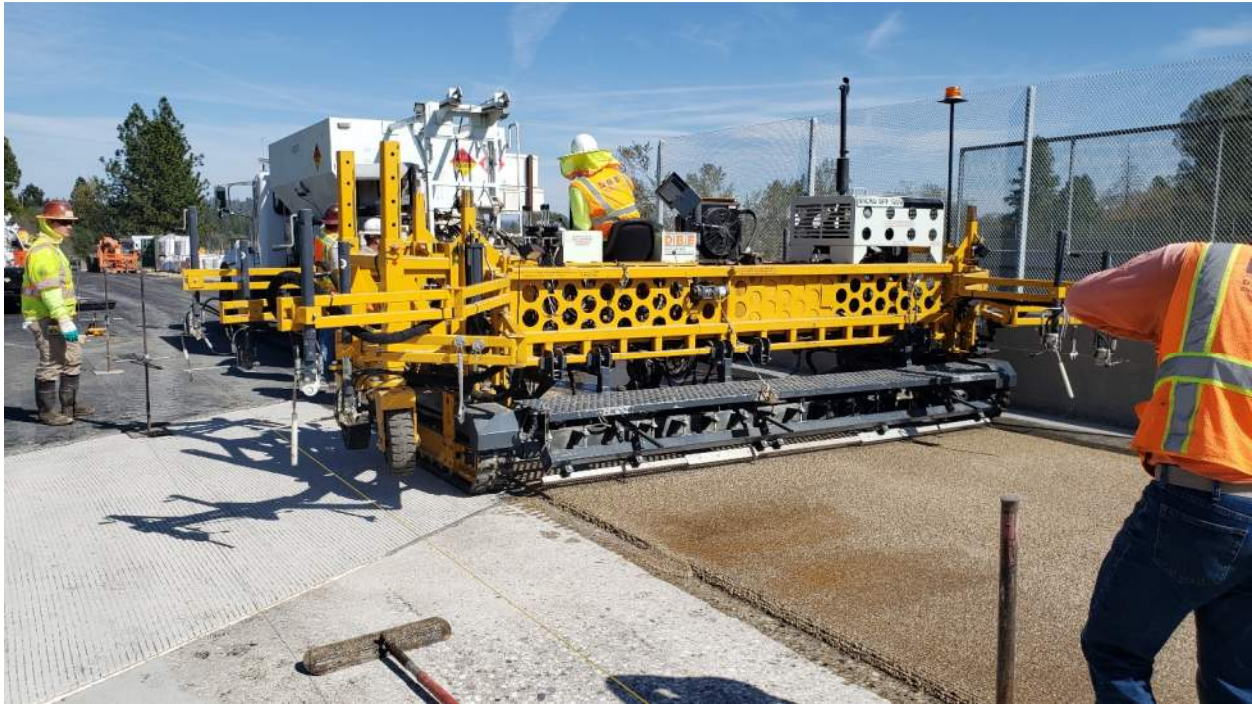
**Figure 13. Polyester Concrete Overlay Installation**

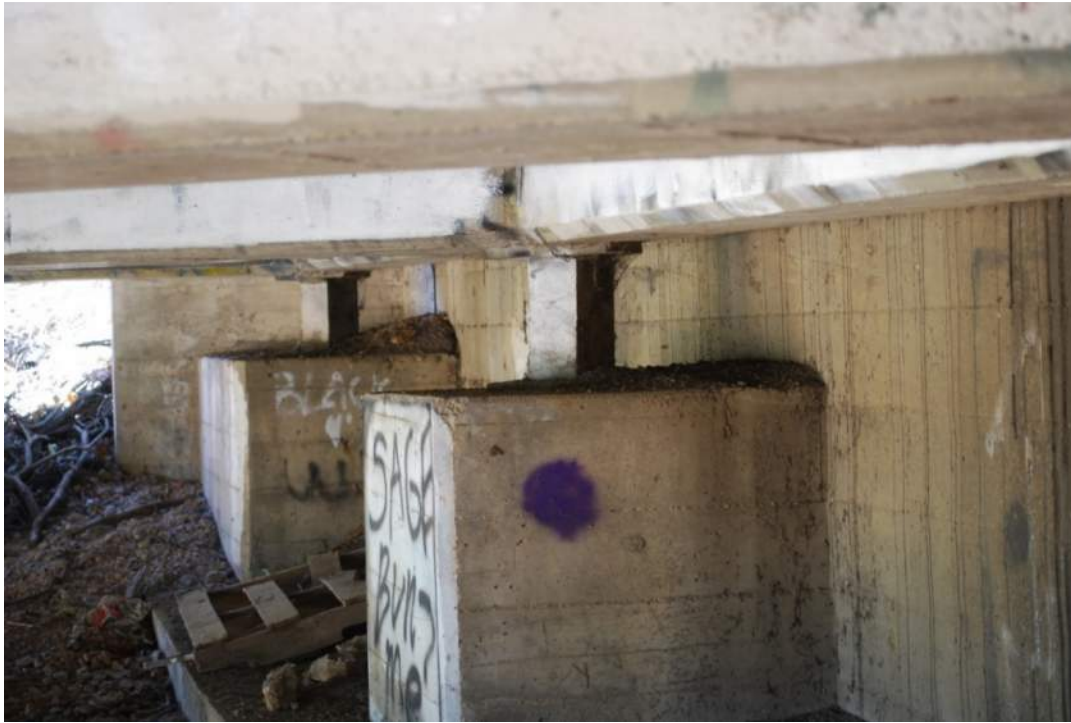
The seismic vulnerability assessment concluded that the main concerns in a seismic event were unseating of the girder rocker bearings (Figure 14) and strength deficiencies in the bent cap and columns. The bent cap beams were deficient for shear and positive moment strength, and the columns were deficient in shear strength.

**Figure 14. Existing Rocker Bearings**

A highly efficient retrofit strategy was developed that involved: (1) Catcher blocks installed between the existing bearing pedestals to mitigate the possibility of excessive seismic displacements unseating of the girders from the rocker bearings and (2) Infill walls between the columns to mitigate the strength deficiencies of the bent cap and columns (Figure 15).

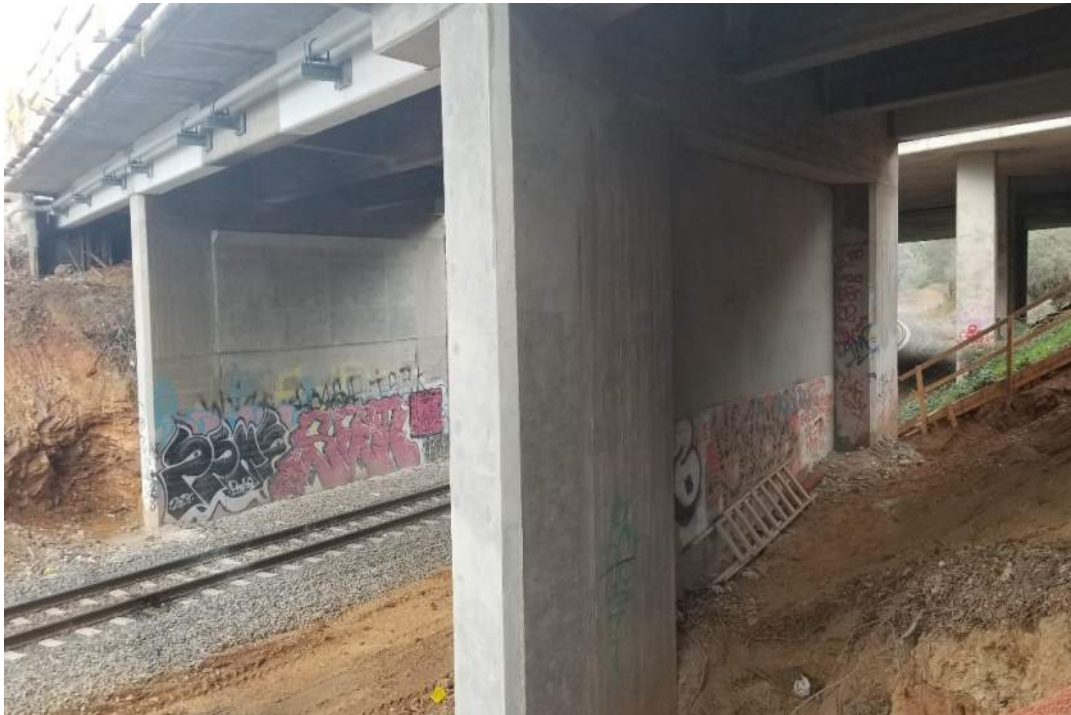
**Figure 15. Completed Infill Walls Installed Between Columns**

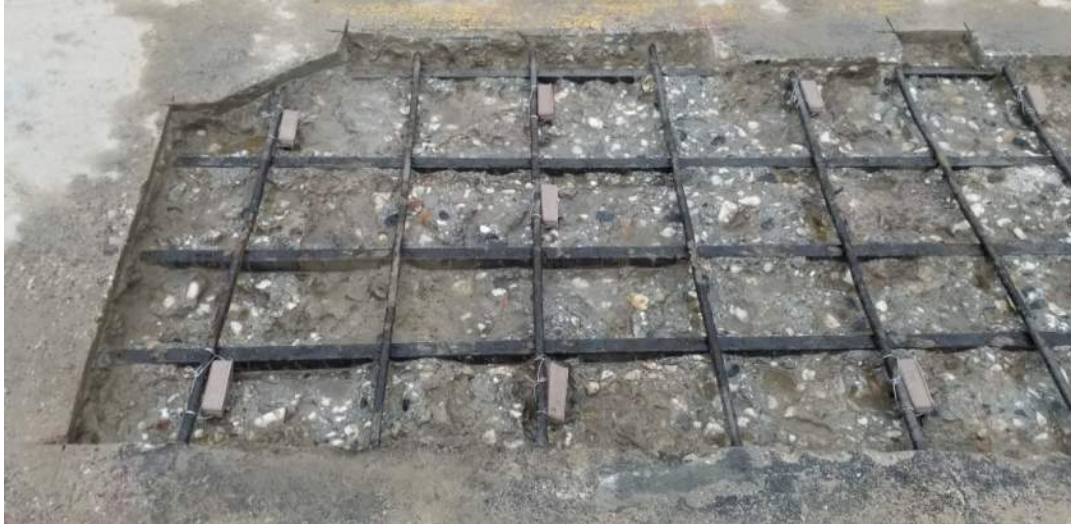
Figure 16. Galvanic Anode Placement

Due to the existence of chlorides in the deck and to mitigate the possibility of future corrosion due at the interface between new and old concrete, galvanic anodes (Figure 16) were placed throughout the replaced deck sections to provide additional corrosion protection and maximize the life of these rehabilitated bridges.
