## Photos- Active Warning Signage for Channelized Right-Turn Lanes

# City Installs New Traffic System to Enhance Pedestrian Safety

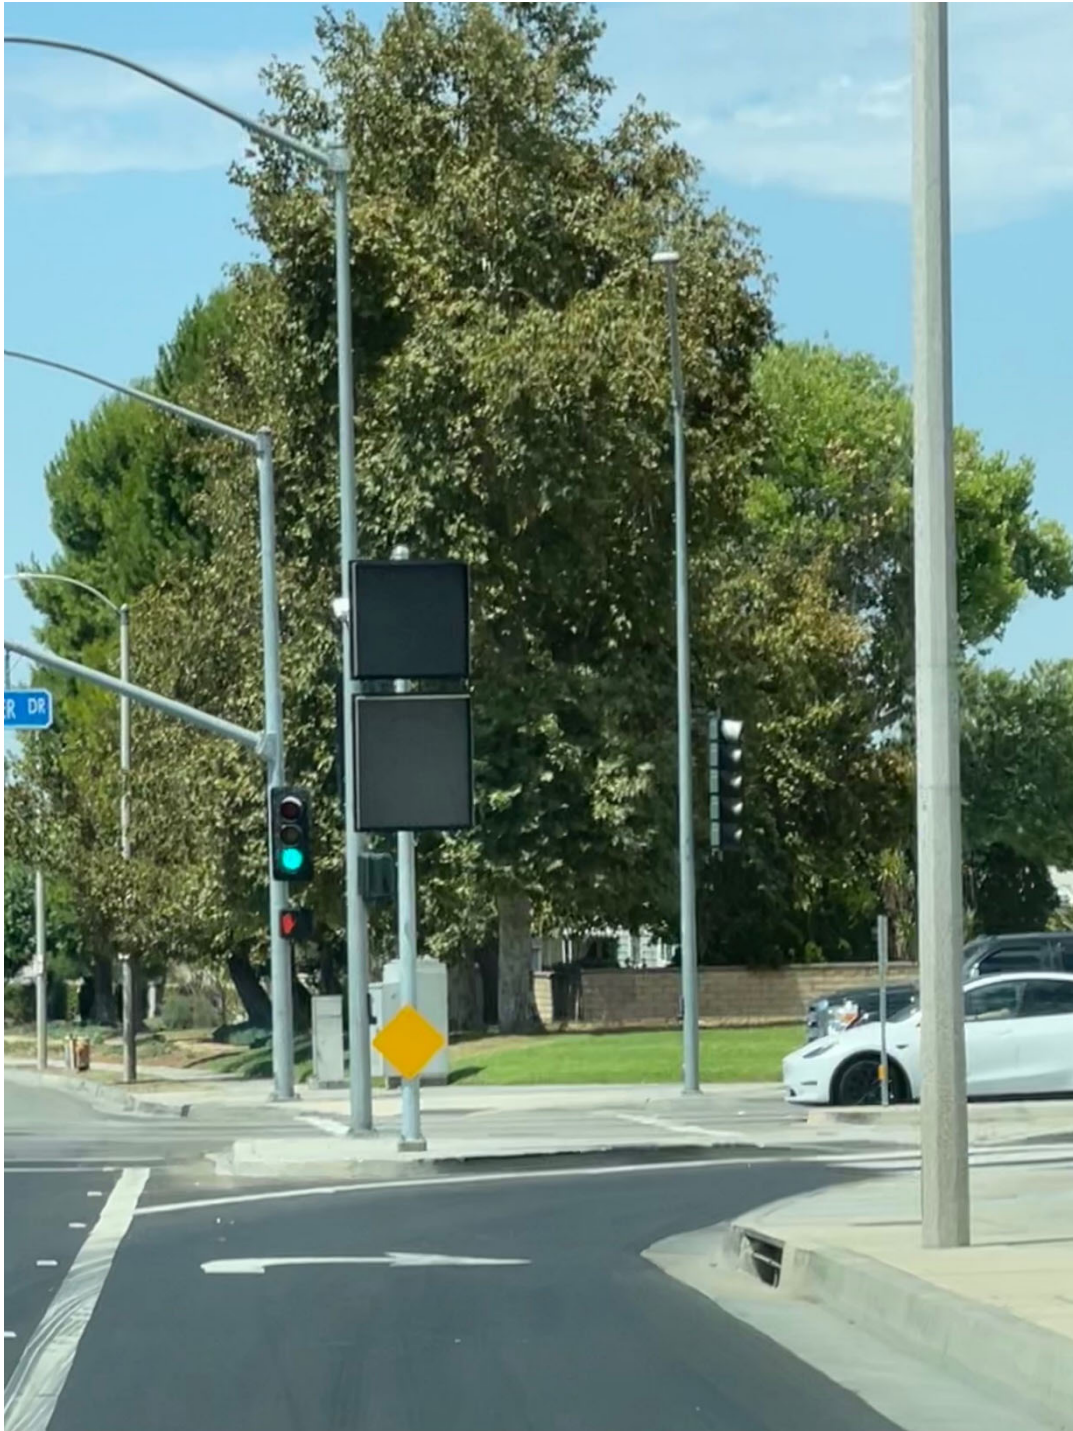
No Pedestrians Present: Active Warning Signage is non-illuminated

The city of Santa Clarita continues to develop new applications to enhance pedestrian safety and improve traffic circulation. A new traffic system was deployed to actively warn right-turning motorists of pedestrians and cyclists approaching a crosswalk. The system, installed at the intersection of Soledad Canyon Road and Valley Center Drive, uses video detection technology to track pedestrians and cyclists to activate an electronic blank-out sign to alert motorists to yield.

The new pedestrian detection system has been installed for motorists driving westbound on Soledad Canyon Road and making a right turn onto Valley Center Drive. It creates an additional layer of safety for pedestrians and cyclists crossing between the sidewalk and the raised channelization island, also known as a "porkchop."

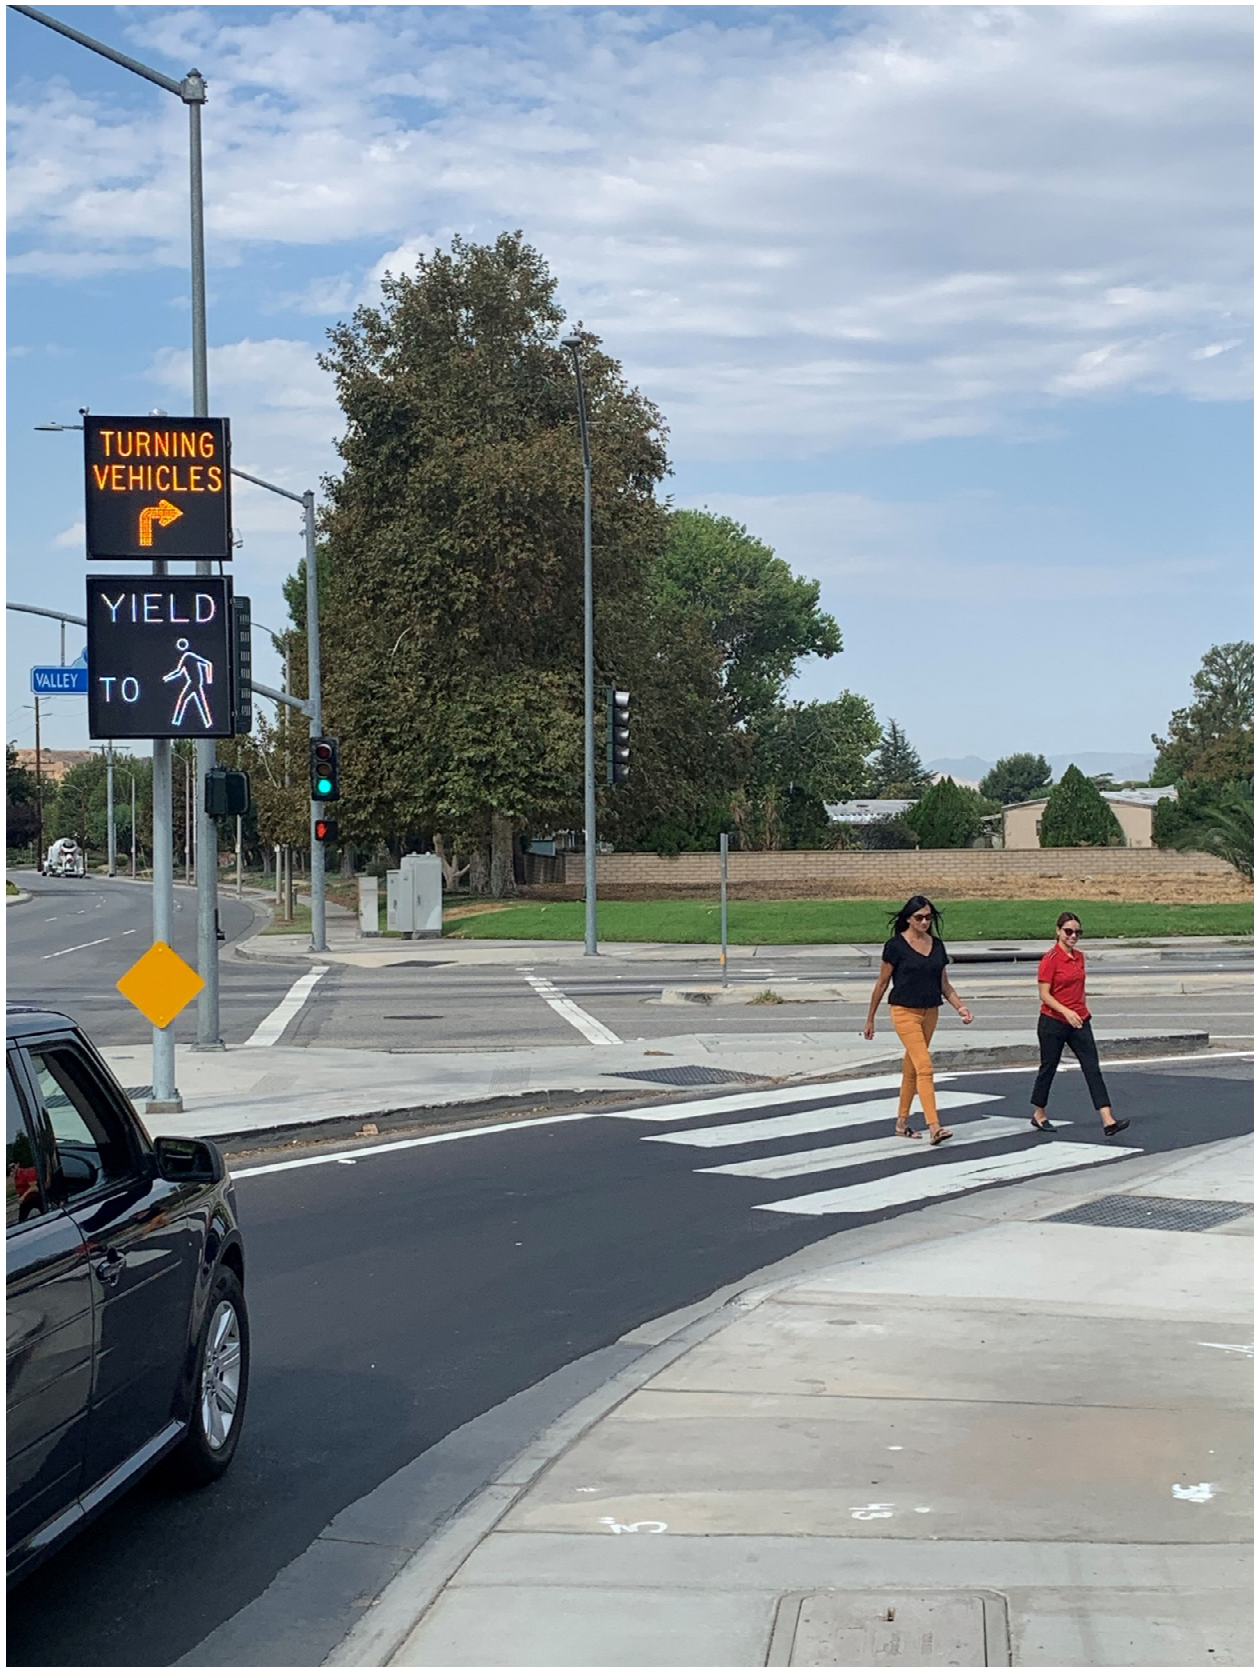
Pedestrians Present: Active Warning Signage is illuminated

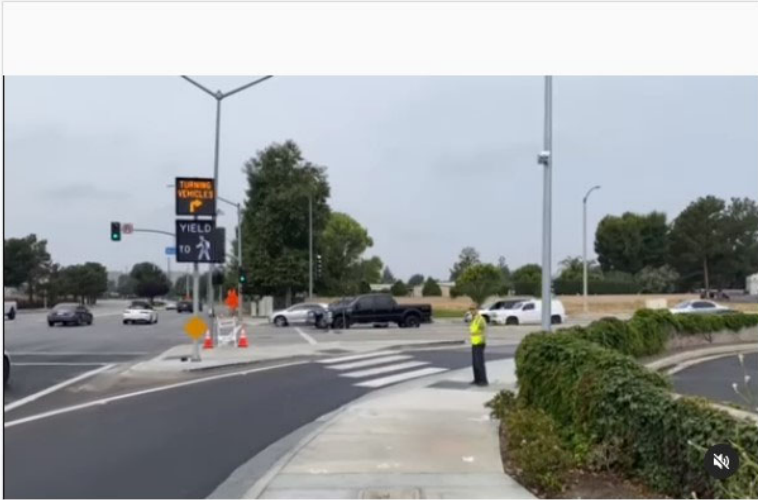
cityofsantaclarita Have you seen it? A new system is in place at the intersection of Soledad Canyon Road and Valley Center Drive that uses video detection to recognize cyclists and pedestrians - before they reach the crosswalk - and alert drivers making a right turn. This system is the first of its kind in Santa Clarita. Check it out!

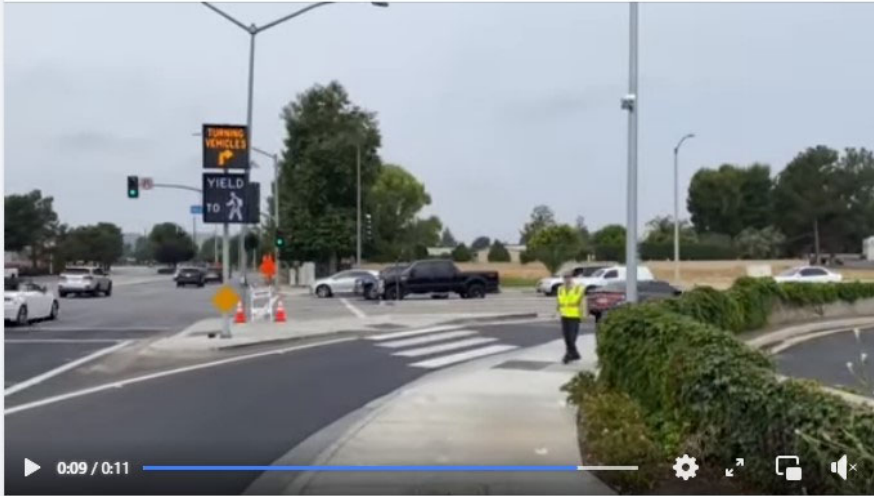
Have you seen it? A new system is in place at the intersection of Soledad Canyon Road and Valley Center Drive that uses video detection to recognize cyclists and pedestrians - before they reach the crosswalk - and alert drivers making a right turn. This system is the first of its kind in Santa Clarita. Check it out!
